Ayşe Gülçin URAL

Fenerbahçe University, Turkey, gulcin.ural@fbu.edu.tr, 0000-0002-9763-8128

Re-Functioning of Pembe Yalı: Evaluation Within the Scope of Turkey Architectural Heritage Conservation Charter and Principles for the Conservation of Wooden Built Heritage

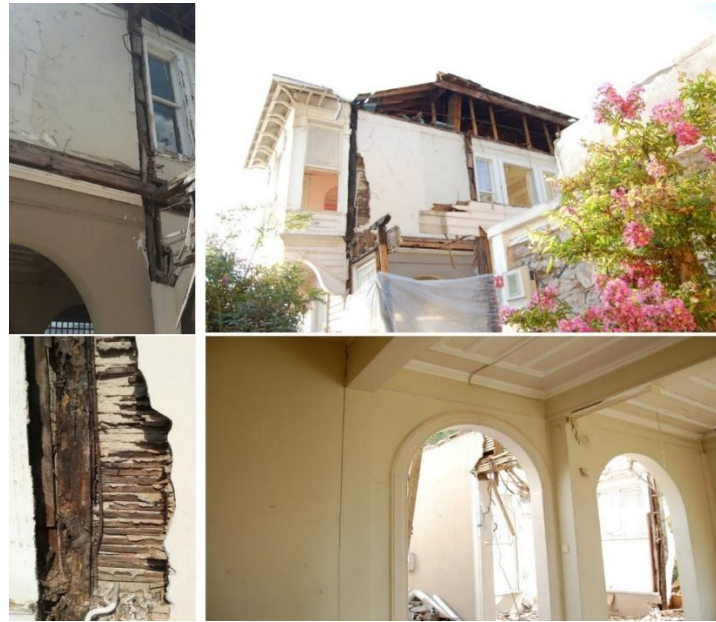
Pembe Yalı, has a void form of approximately 110 cm in its foundation under the ground. The wooden load bearings were damaged and decomposed to a great extent. The walls of the wooden load bearing system are plastered. There are neatly cut laths on the walls (Figure 2). While some parts have straw added lime plaster, some parts have been intervened with cement²³.

Figure 2. Rotten Wood Prop, Baghdadi Cement Over Lath, Pembe Yalı Interior, Damage Caused by Reinforced Concrete and Steel Columns Added to the Structure for Strengthening (Author, 2017).

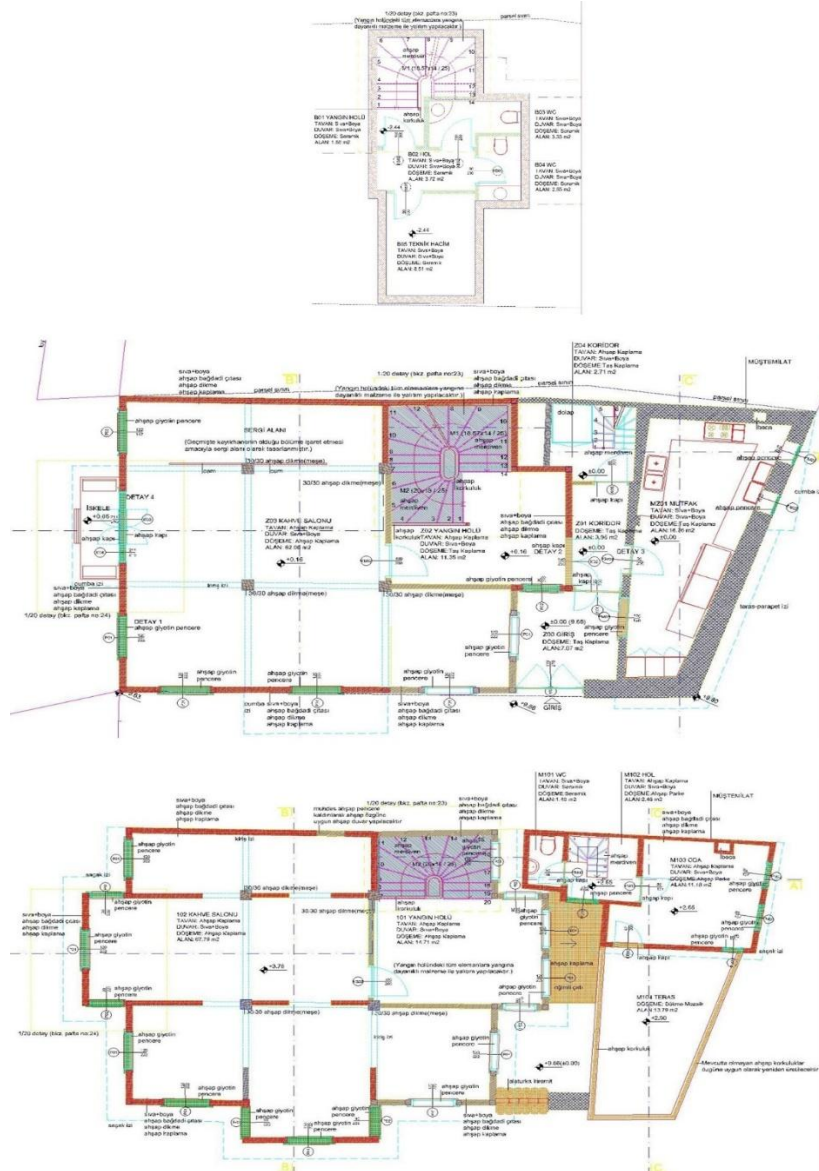
Upon starting the recording and reparation of the structure, it was found out that most parts of the main building were weathered (Figure 4). In addition, no record of the architectural and historical properties of the building (approved survey and restitution projects, recording and approval drawings related to simple repairs) could be found in the archives of the Directorate for Foundations. Hence, detailed survey drawings of the building were drawn based on the principles set forth in Article 16 of the Venice Charter and the declaration of ICOMOS (International Council of Monuments and Sites) titled "Principles for the recording of monuments, groups of buildings, and sites" and the structural elements preserved in their original form and the adscititious elements are indicated. During the recording process, the integrity of the building was

Figure 4. Basement Floor Plan, Ground Floor Plan, 1. Floor Plan (Author, 2017).

Based on the inspection and recording carried out, it was concluded that the load bearing of the structure was significantly damaged due to the factors below, which also led to the collapse of a part of the structure:

- The load bearing system of the building was damaged through the removal of the partition walls of the building,
- The steel and reinforced concrete column which replaced the removed partition walls do not function in accordance with the wooden structure,
- The building load was increased because of the concrete laid on the decaying floor of the bathroom.
- The foundation, wooden covers, and bearing elements of the mansion were exposed to and damaged by environmental factors including highly abrasive sea water, rainwater, insects, etc.
- In addition, it was observed that no protection and repair work was carried out during the period when the considered structure was weathered due to the abovementioned effects.

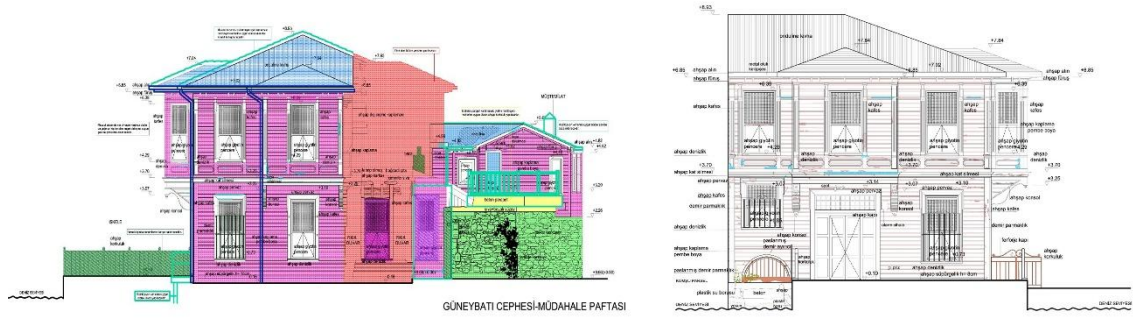
Figure 5. Southwest Front, Sea Front (Author, 2017).

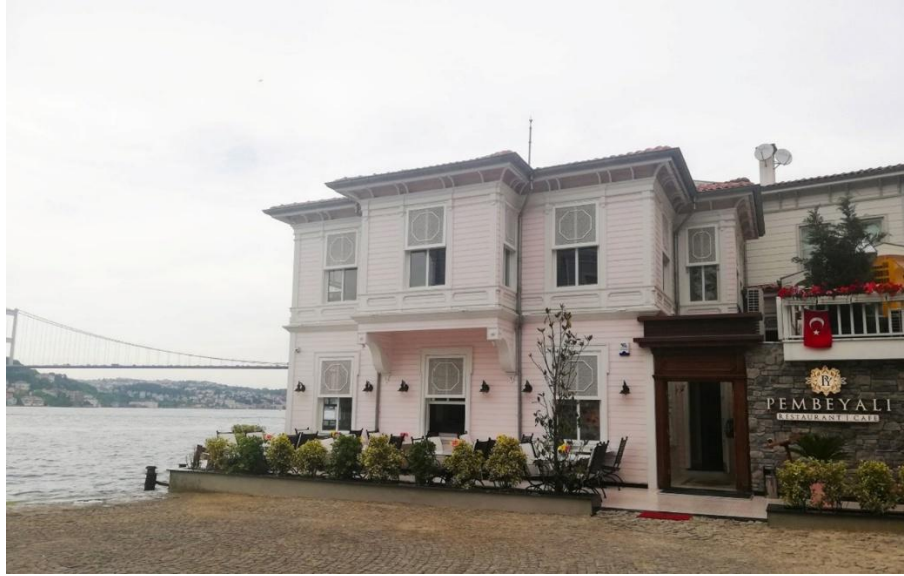
Figure 6. Post Restoration Entrance Facade (Author, 2020).

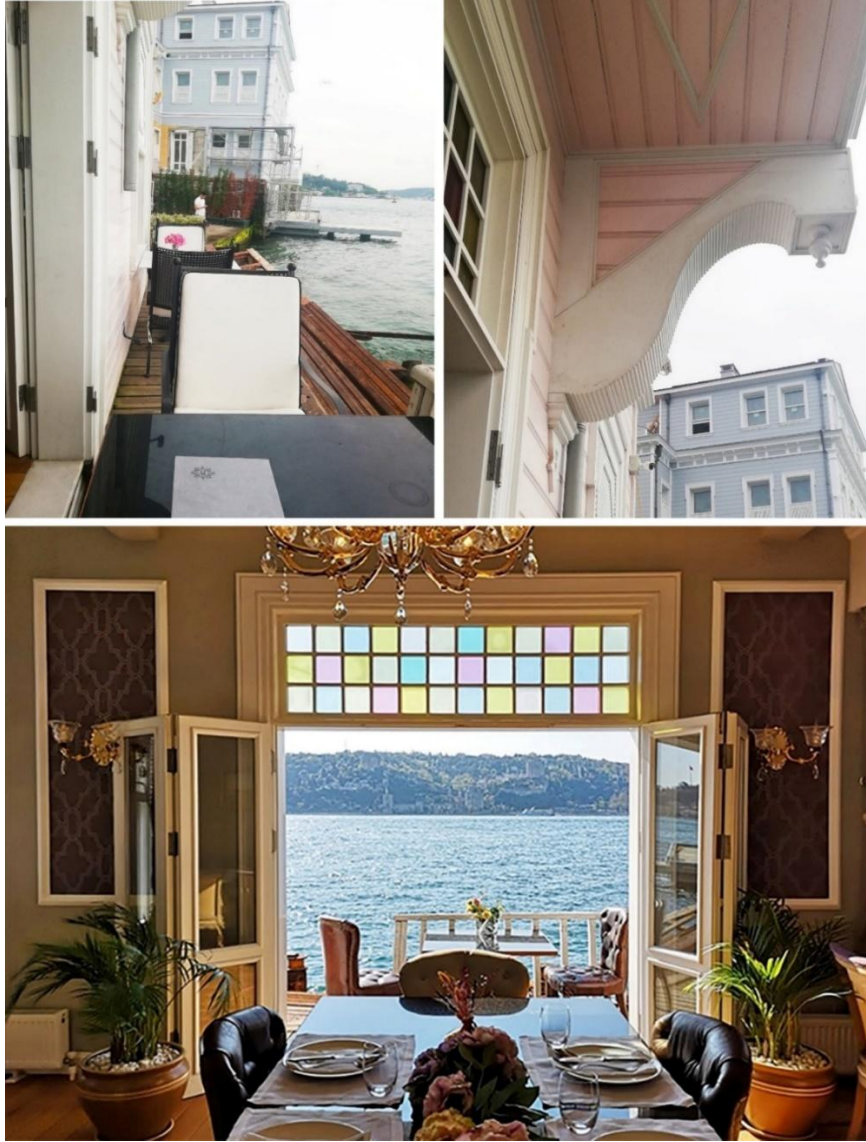
Figure 7. Restoration Scaffolding Section (Author, 2020).

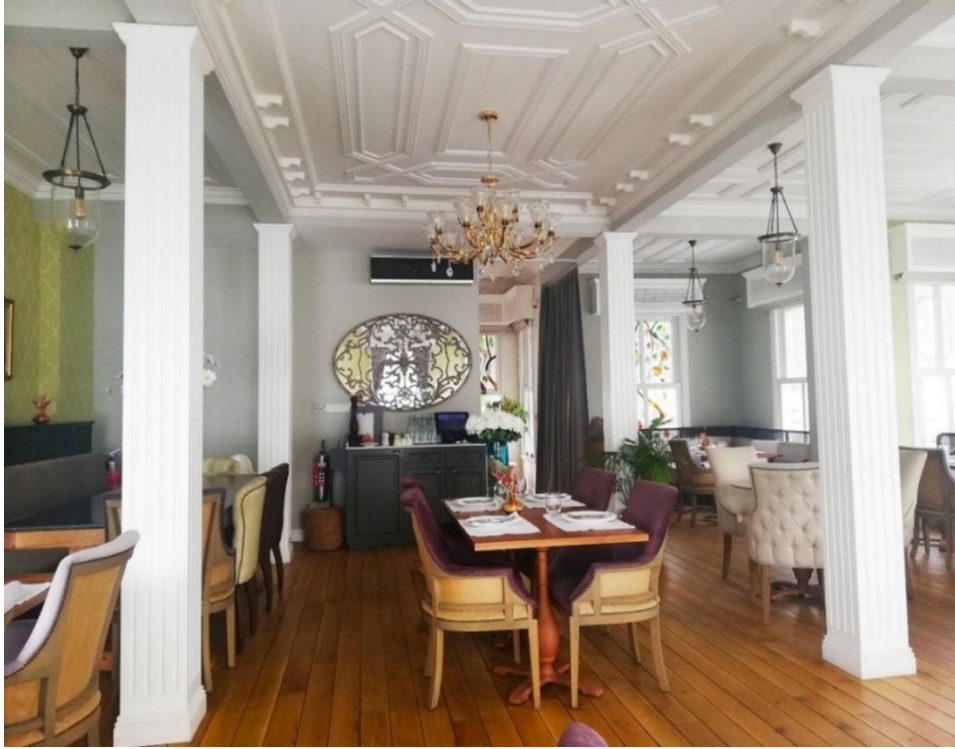
Figure 8. 1. Floor after Restoration (Author, 2021).

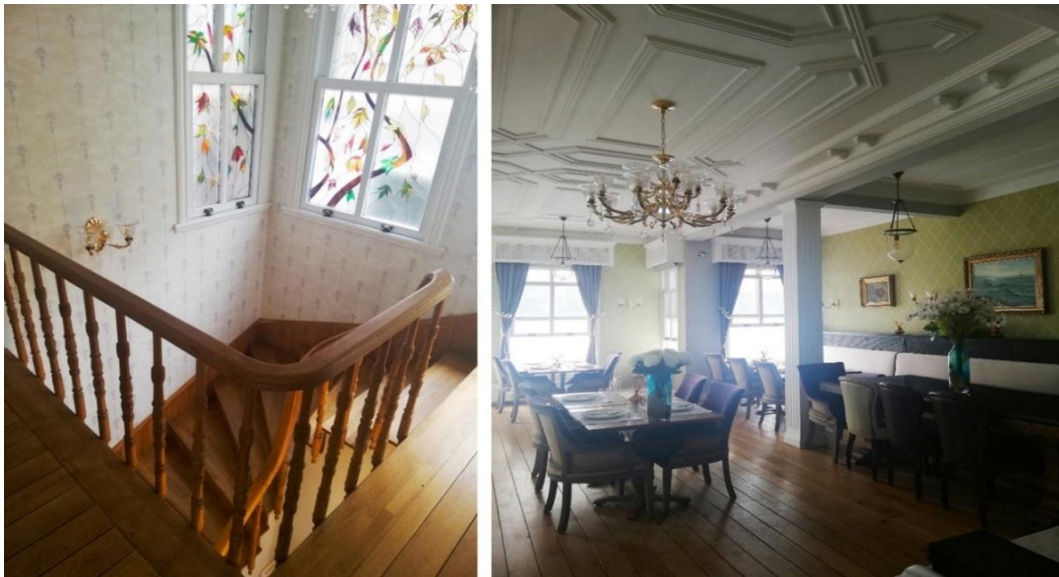
Figure 9. Stairs After Restoration and 1st Floor (Author, 2021).
