# Osmanlı Mirası Araştırmaları Dergisi

## *Mescitten Camiye: Çorum İnyetullah Camii’nin Tarihsel Süreci İçinde Mekansal Değişimi Üzerine Bir İnceleme*

### *From Masjîd to Mosque: A Study on the Spatial Change of Çorum İnyetullah Mosque in Its Historical Process*

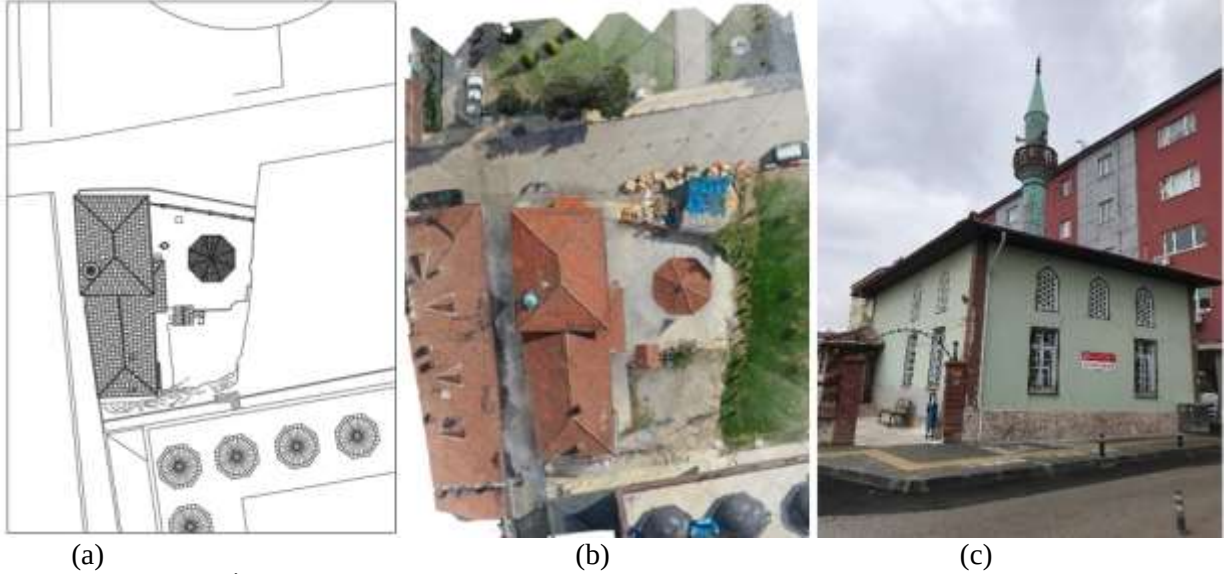
The İneyetullah Mosque, located in the Karakeçili Neighborhood of the İneyetullah Mosque, draws attention with its original rectangular planned prayer room, wooden ceilinged prayer room, muezzin, and women's gallery in the north, and wooden minaret. The Quran course structure added to the north of the mosque includes an additional last congregation place, a women's section and toilets on the ground floor, and men's toilets in the basement. There is a fountain in the west and northwest of the building and a wooden fountain in the west. A new stone-coated, domed two-story structure was built west of the mosque (Figure 1). The mosque is reached from the south through an opening with brick-coated bollards to the west of the courtyard.

Figure 1. a. İneyetullah Mosque Site Plan, b. Aerial view, c. View from west and south sides.

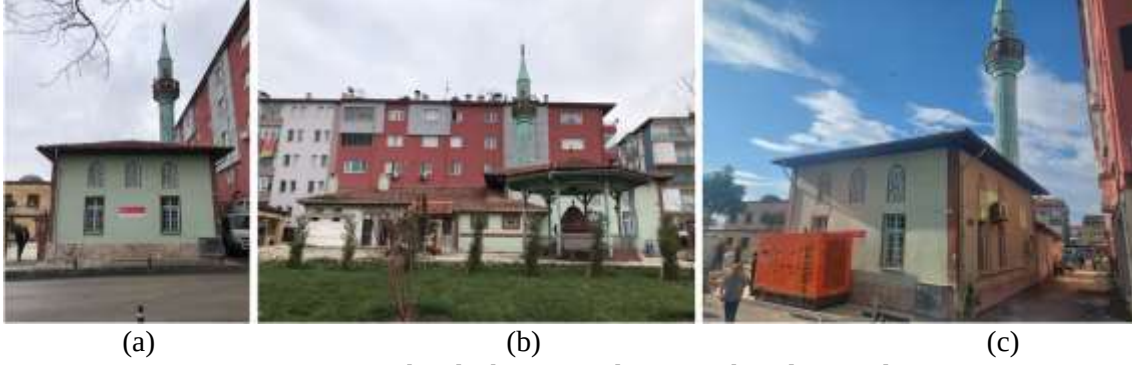
The northern wall is blind, with two toilet doors on the north side and two rectangular windows with wooden joinery. Five additional windows of the same type are on the east side (Figure 2).

Figure 2.a. South side, b. West side, c. South and east sides.

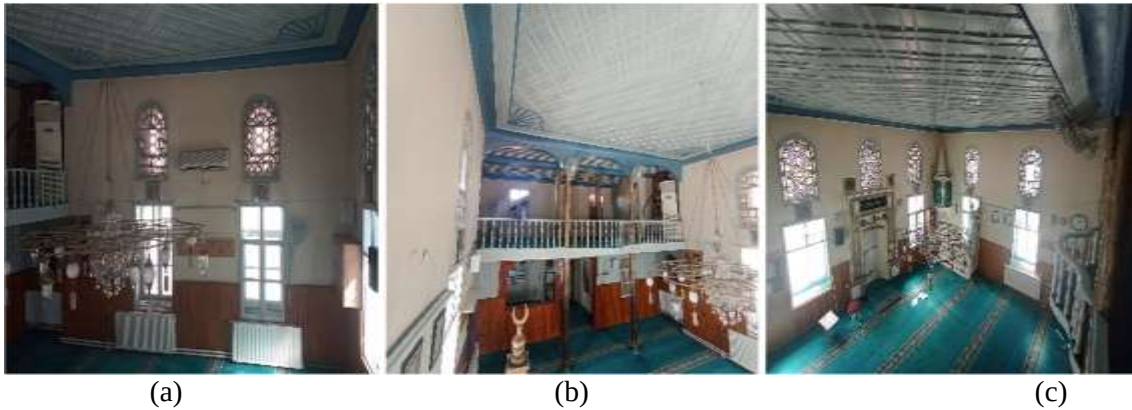
The upper windows are stained glass, featuring orange, green, yellow, and burgundy geometric motifs. The mihrab is at the center of the qibla wall, with a pulpit in the west corner and a cupboard in the east. The ceiling, corner seats, and fan-shaped details are painted blue, while the slatted sections are white. The walls are wood-paneled up to 1.25 meters, with beige plaster above. The floor is covered with wood and carpet (Figure 3).

Figure 3. a. Harim east side, b. view from the harim, c. View of the Harim from the south and west sides.

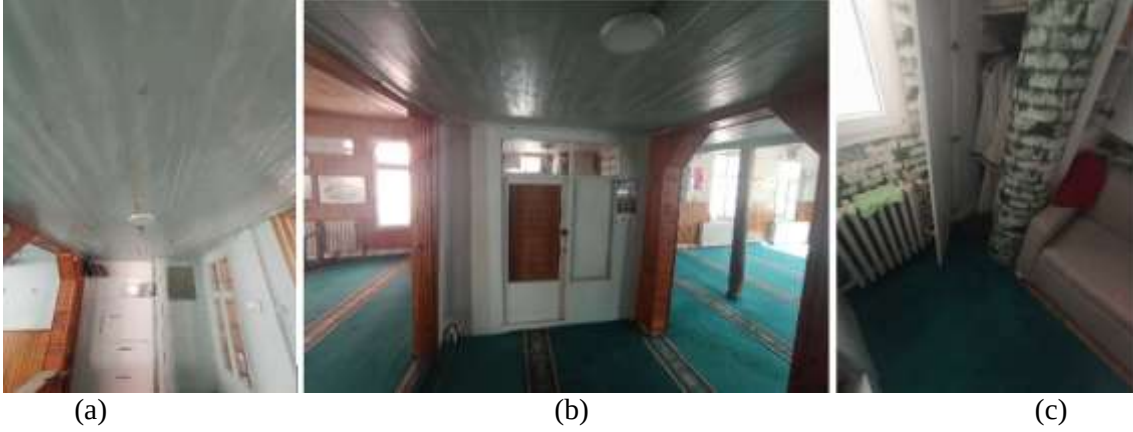
is raised one step and bordered by a wooden railing. In this section, the wooden door of the staircase provides access to the women's gallery on the upper floor. To the east is the Muezzin's Room, which is accessed through a wooden door. The gallery's ceiling is covered with wooden paneling (Figure 4).

Figure 4.a. Muezzin's Mafil Stairs, b. The Muezzin's Room, c. View from the Minaret Core.

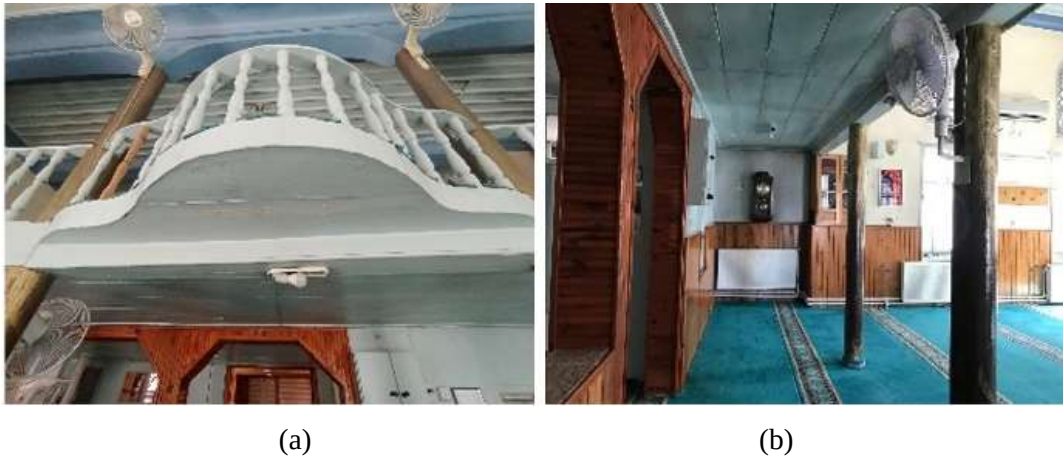
The women's gallery extends over the muezzin's gallery, supported by square-sectioned wooden posts. The gallery's center, which extends towards the prayer hall, has rounded lines with curved sides. Railings around the wooden console maintain the gallery's architectural integrity. The ceiling is divided by a beam supported by square posts, with wooden slats and a wooden-coated floor reflecting traditional craftsmanship. The wooden beams and ceiling corner seat moldings are painted blue, while the rest are left white (Figure 5).

Figure 5.a. Protrusion of mahfil, b. Mahfil lower ceiling covering

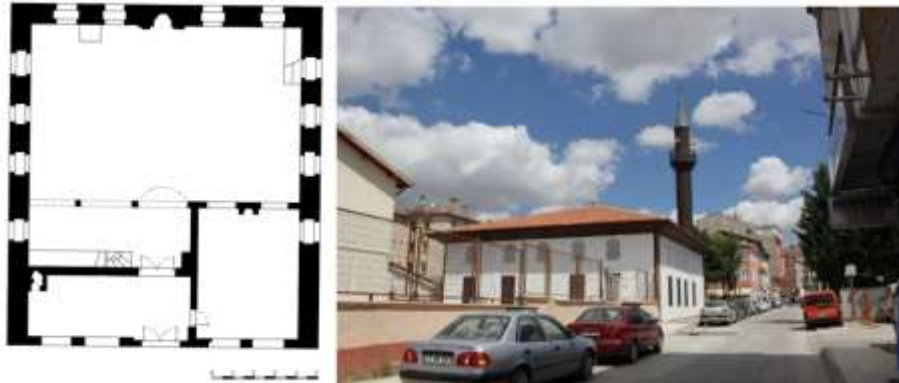
Figure 7. a. Abdalbaki Mosque plan b. West and south façade .  
Source: Abdulkadir Dundar, Adem Sevim

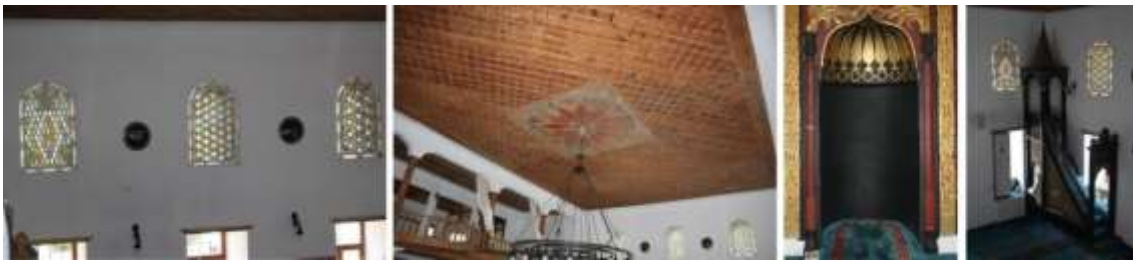
Built on stone foundations, the mosque's north, west, and east walls are made of adobe brick masonry and wooden beams, while the north façade uses a half-timbered technique. Restorations in 1865 and 2004 preserved the mosque's structural and decorative elements<sup>34</sup>. The Abdülbaki Pasha Mosque shares similarities with the İnayetullah Mosque, including the wooden ceiling, gallery, lower-level last prayer area, and wooden minaret. It also features a semicircular

mihrab niche and a wooden pulpit, retaining traditional Ottoman mosque architectural characteristics (Figure 8).

Figure 8. a. Upper Windows, b. Ceiling of the Harim, c. Mihrab, d. Wooden Pulpit <sup>35</sup>  
Source: Adem Sevim

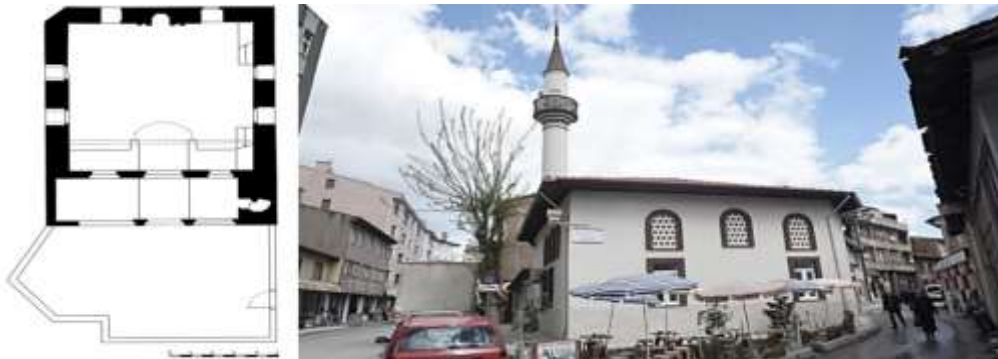
The Çakır Mosque features a square-planned prayer hall and a trapezoidal courtyard to the north. The last prayer area, enclosed on three sides, is accessed through a flat-ribbed door and includes two quadrangular windows with flat lintels. The mosque's wooden minaret, accessible from both the last prayer area and the gallery, has a polygonal form with convex moldings below the balcony and a decorative belt of small square motifs between the balcony corbels. The mosque's fenestration follows a structured arrangement, with a 2+2+2 pattern in the lower row on the east, south, and west façades and a 2+3+2 arrangement in the upper row. The lower windows are flat-lintels and quadrangular, while the upper windows incorporate round-arched plaster grids, pointed arches, and interior stained glass elements (Figure 9).

Figure 9. Çakır Mosque Plan, Görsel 12: View of South Side<sup>36</sup>

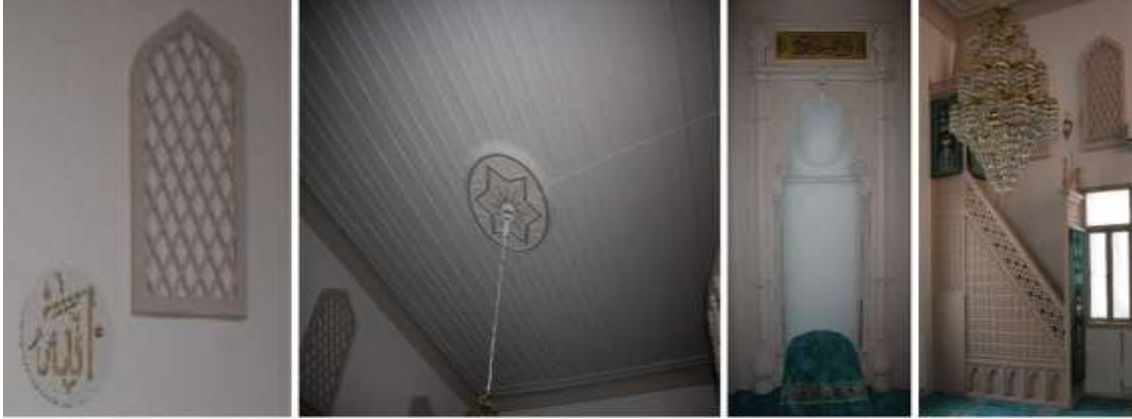
The last prayer area has been enclosed and integrated into the gallery, which is accessed through a flat-ribbed door leading to the Harim. The gallery ceiling, featuring a central navel extending in the east-west direction, is adorned with long and thin çıtakari rectangles. Supported by wooden beams and two quadrangular-sectioned wooden pillars, the ceiling structure integrates seamlessly with the harim. The mosque's mihrab is a semicircular niche with a quarter-sphere hood and an eyebrow arch, remaining undecorated, while the pulpit is constructed of wood<sup>37</sup>(Figure 10).

Figure 10.a. Upper Windows, b. Ceiling of the Harim, c. Half-Circular Profile Niche and Quarter Sphere Arched Mihrab, d. Wooden Pulpit<sup>38</sup>

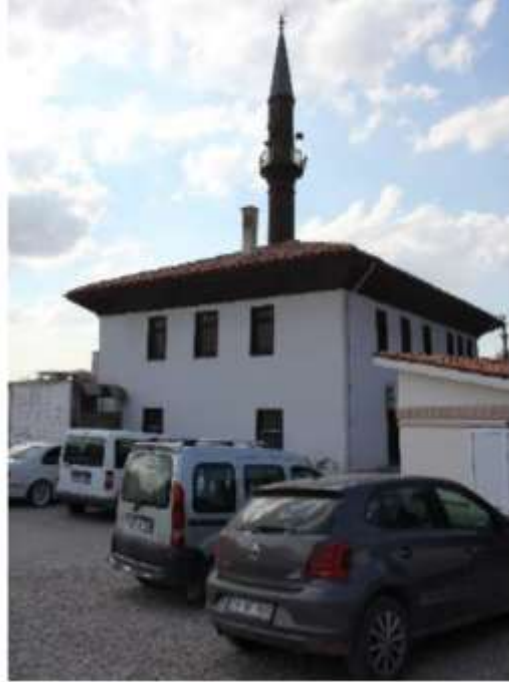
Figure 13. a. Kunduzhan Mosque Plan, b. East and North sides<sup>44</sup>.

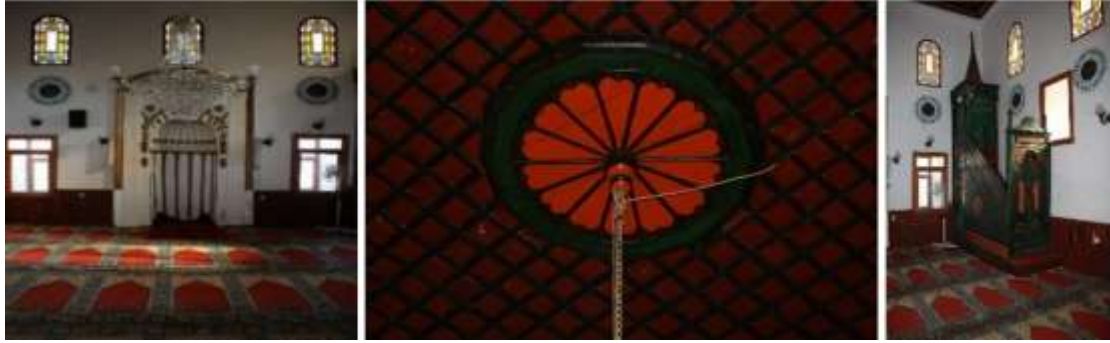
The Kunduzhan Mosque features a rectangular prayer hall extending longitudinally towards the mihrab, with a last prayer area to the north and a courtyard beyond. The last prayer area is accessed through a wooden glass-paneled door, enclosed on the west by the minaret base and on the east by a wall. The north façade facing the courtyard has wooden glass-paneled elements. The upper section of the last prayer area includes a room on the east side, while the wooden minaret stands to the west. The minaret's door to the last prayer area is sealed, and access is through the gallery. The polygonal minaret body is structurally decorated with slats, a bracelet near the balcony, concave and convex moldings, and an iron railing. It is topped with a pyramidal cone, honeycomb cover, and a two-node finial. The mosque's windows are generally rectangular, except on the southeast façade, where the upper windows feature pointed arches and stained glass. The roof is hipped and tiled (Figure 13).<sup>42</sup>

In the 18th century, several masjids in Çorum were converted into mosques to increase their capacity, leading to significant changes in their architectural plans. These transformations are evident in the structures of mosques such as Kunduzhan, Kulaksız, and Kellegöz, which underwent repairs in the 19th and 20th centuries, bearing traces of these adaptations.

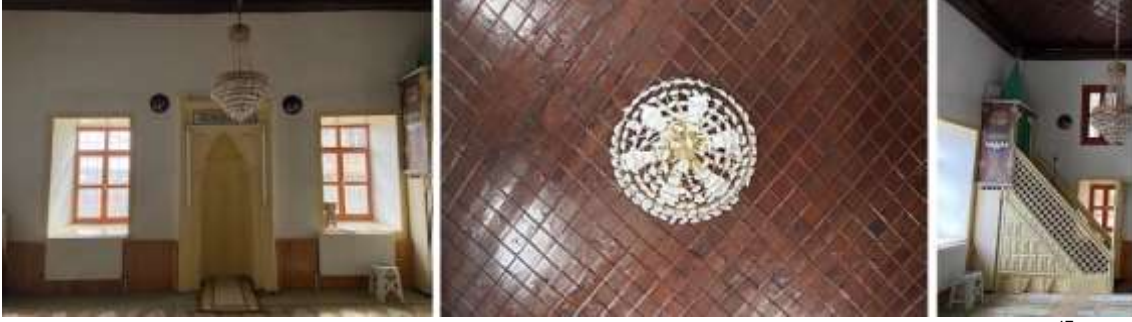
Figure 16. a. Mihrab Façade Windows, b. Wooden Ceiling Hoop, c. Wooden Pulpit<sup>47</sup>

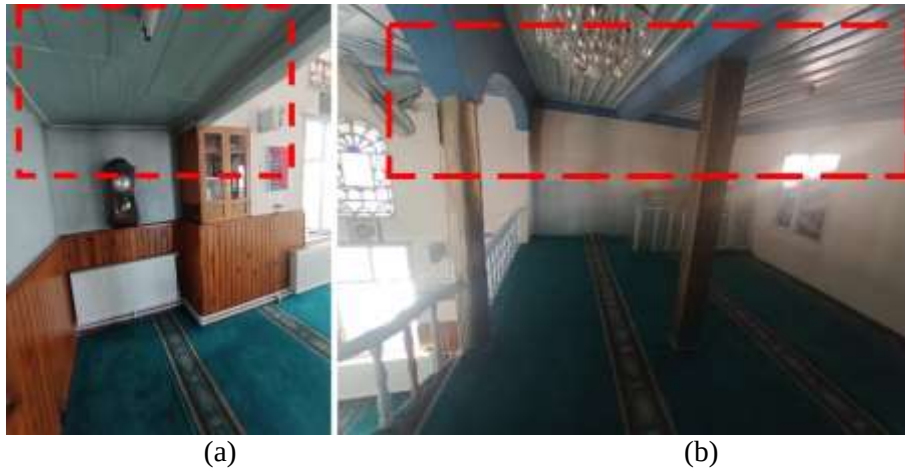
The women's mahfil, located in the northern section of the Harim, is supported by two wooden columns, with the middle section protruding as a balcony. Access to the gallery is via an L-shaped wooden staircase on the eastern wall, comprising ten steps. The gallery floor is made of plain wood, while the ceiling is covered with slatted timber.

Figure 17.a. Trace of the Closed Exit of the Gathering Stairs on the Gathering Ceiling Covering, b. Lathed Ceilings of the Gathering and Last Congregation Place on the Gathering Floor.

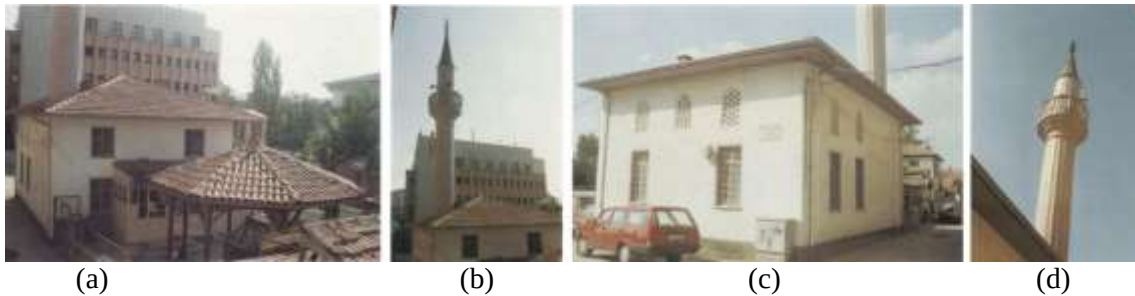
**Third Period Pre-2003 Repairs:** Since the date of the repairs made until 2002 cannot be determined, it is presented as a period before 2003. Information on the condition of the mosque before 2002 and the repairs afterward is obtained from the book of Prof. Dr. Abdülkadir Dündar. In these repairs, a glass-fronted entrance was added to the north entrance of the mosque, and the front of the northwest window was closed. The glass-fronted annex has a canopy roof. A toilet was added to the northeast corner of the north courtyard of İnayetullah Mosque, and an octagonal wooden fountain was added in the middle in 1963 (Figure 18).<sup>55</sup>

Figure 18. a-b. Glass Window, Fountain and Toilet in Front of the North Façade, c.South and East Sides, d. Minaret (2002)<sup>56</sup>  
Source: Abdülkadir Dündar

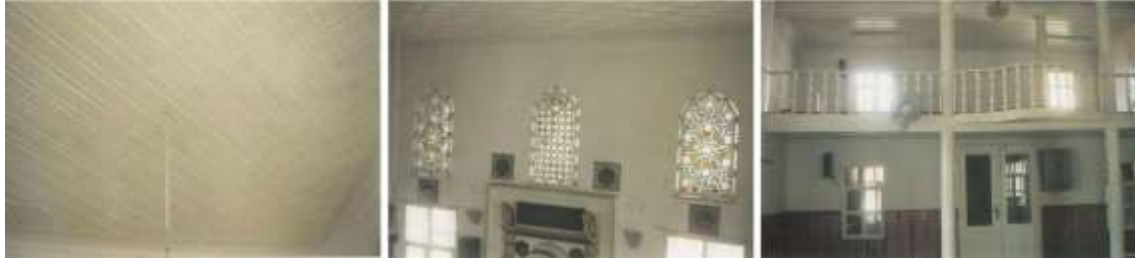
It is seen from the pictures that the façades, wooden minaret interior walls, and architectural elements are in a single color (off-white/beige). The walls inside the mosque are covered with wooden paneling. Radiator radiators have been added (Figures 19-20).

Figure 19.a. Celing of Harim, b. Stained Glass Windows, c. Mahfil Floor (2002)<sup>57</sup>  
Source: Abdülkadir Dündar.

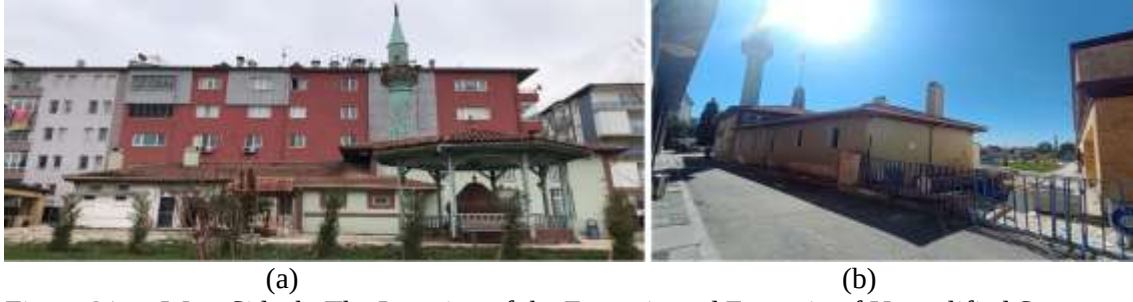
**Fourth Period Repairs After 2003:** During the renovations carried out by tradespeople in 2003, several changes were made to the mosque and its surroundings. The glass window in front of the northern main door was removed, and the toilets in the courtyard were dismantled. Additionally, the fountain was relocated to the west side of the courtyard. The space vacated by these alterations on the northern side of the mosque was enclosed entirely in front of the north wall.

Figure 21. a. West Side, b. The Location of the Fountain and Fountain of Unqualified Structures Joined from the North Side (2024)

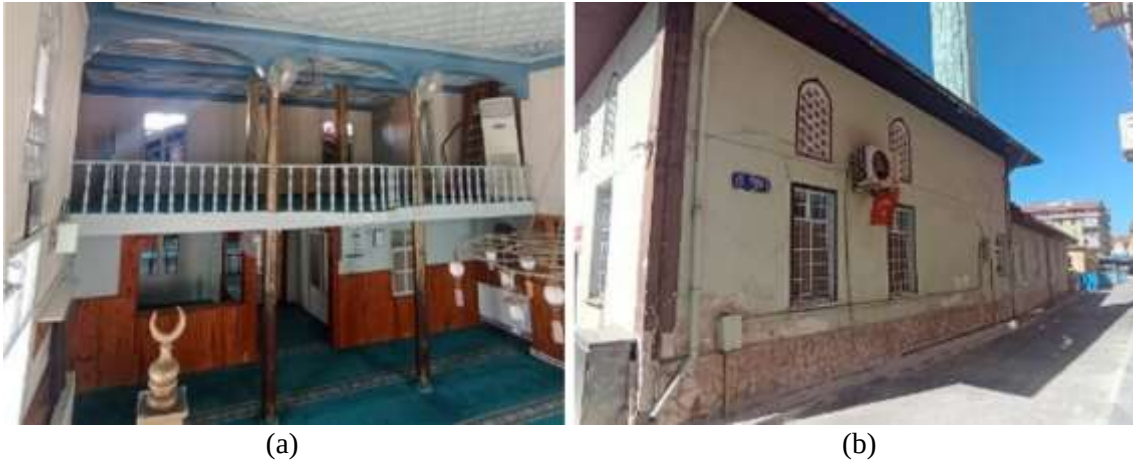
A new space was created on the eastern side, beneath the gallery in the last congregation area. A smaller window, distinct from the lower windows on the mosque's eastern façade, was inserted into the main wall to illuminate this space. Additionally, an opening was made in the western wall and covered with wooden paneling (Figure 22).

Figure 22. a. Mahfil's inventions, b. Window of the Muezzin's Room on the North Side
