Cilt 12, Sayı 32, Mart 2025 / Volume 12, Issue 32, March 2025

Atıf/Citation: Erten Bilgiç, Didem. "Acquisitions And Concessions In Preserving Cultural Heritage: The Hagia Sophia Roxelana Bathhouse". *Osmanlı Mirası Araştırmaları Dergisi* 12/32 (2025): 77-101.

Acquisitions and Concessions in Preserving Cultural Heritage: The Hagia Sophia Roxelana Bathhouse*

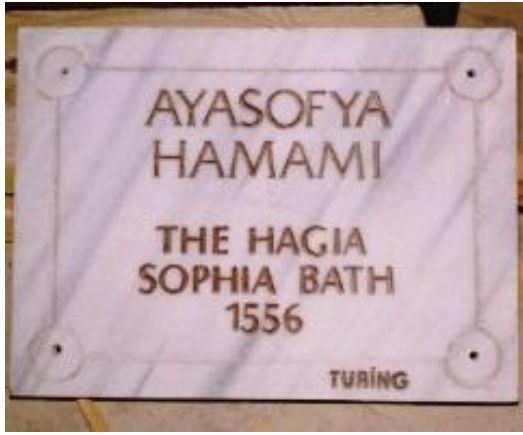
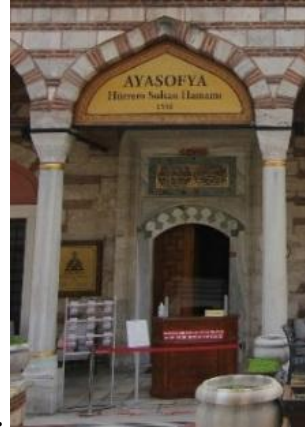
Image 1. a. The name of the building is mentioned as "Hagia Sophia Bathhouse" in the photo album of the restoration made in 1961, as in the previous records. b. The marble signboard shows the name of the building during the restoration between 1986-1989. c. The signboard of the building after the restoration was completed in 2011.

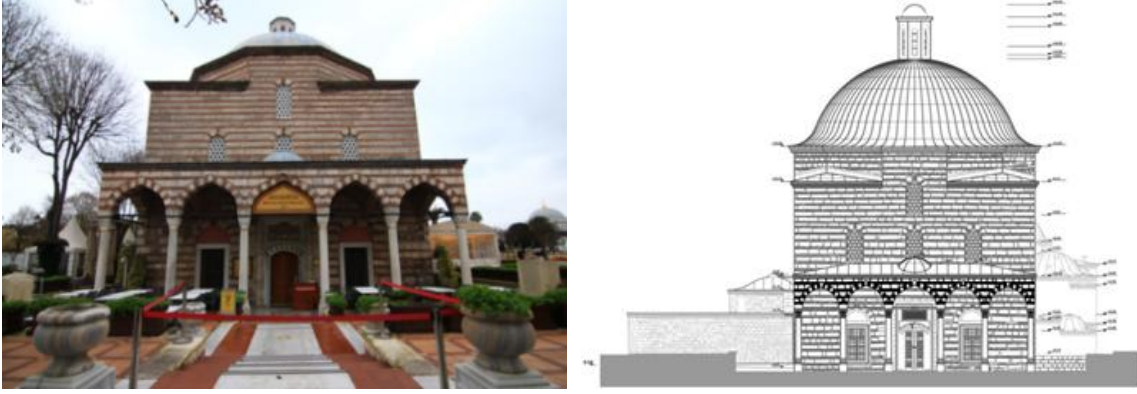
Image 6. Photograph of the men's entrance door of the bathhouse in December 2020 and a survey drawing of the entrance façade (author's archive).

than emphasizing the façade, providing entrance and exit comfort depending on weather conditions, and increasing the architectural effect (Image 6).

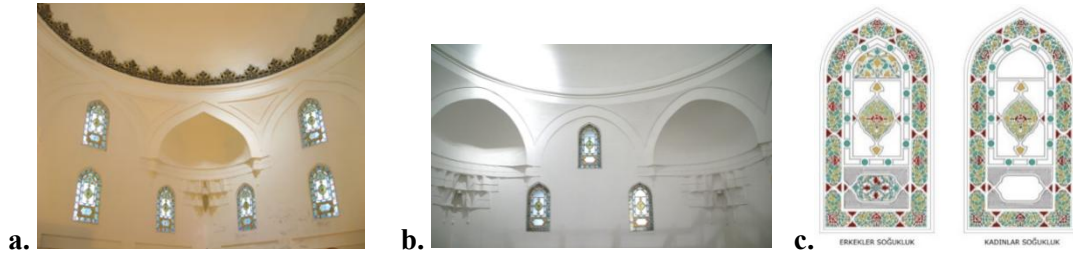
Image 12. Photographs from 2010, when the changing rooms in the cold section, which is accepted as a 1986 addition, were dismantled during the restoration. In the pictures where the revzen windows, dome decorations, and muqarnas can be observed comparatively, the one on the left (a) belongs to the men's cold room and the one on the right (b) to the women's cold room, c. In the drawings made for the revzens in the cold sections during the survey studies, it is seen that there are fewer embroidered applications in the women's section compared to the men's section (author archive).

The dome in the men's cold room is decorated at the level of the pulley in the interior and is slightly higher than the dome of the women's cold room, as seen in the façade drawing. The dome of the women's cold room is not decorated in the interior (Image 12).

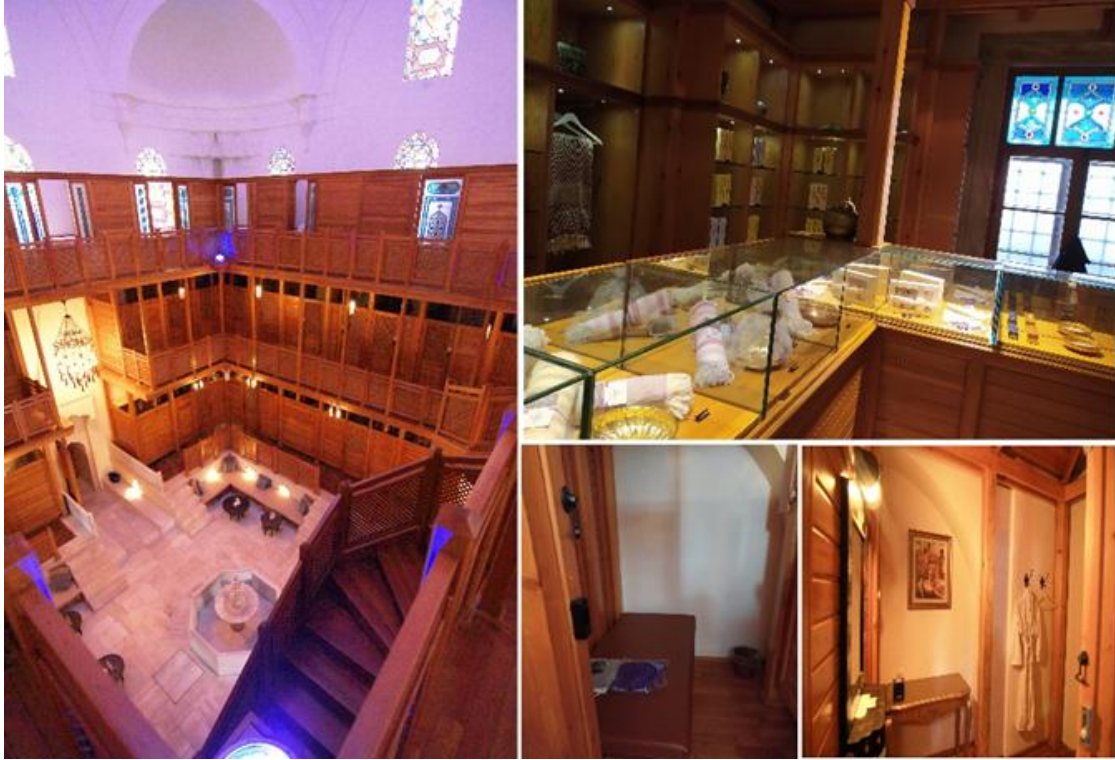
Image 13. Photographs from the men's section cold room in 2021 (author archive).

The lower elevation of the bench areas, which are accessed by steps from the central area of both cold rooms, is equipped with 28 shoe niches in the women's section and 32 in the men's section. There are no changing cabins in the original condition of the building. During the 1986 restoration, the wooden construction changing cabins, which are thought to have been added, was renewed in the 2009 restoration as a period addition using cedar wood. By taking advantage of the sectional height of the dressing room, changing cabins, massage rooms, and resting places were organized on the floors created from wooden construction. In the hammam, which provides services through cultural tourism, the addition of volumes that are not present in the original may interfere with the provision of cultural continuity and may offer different experiences for those who will experience the place for the first and only time. The shoe niches, which became dysfunctional with the addition of changing cabins to the upper levels, were also evaluated as decorative ornamentation tools. Visiting tourists have no idea about the original use of these niches. Stands where necessary materials and memorabilia are sold according to the content of the service provided in the space (Image 13).

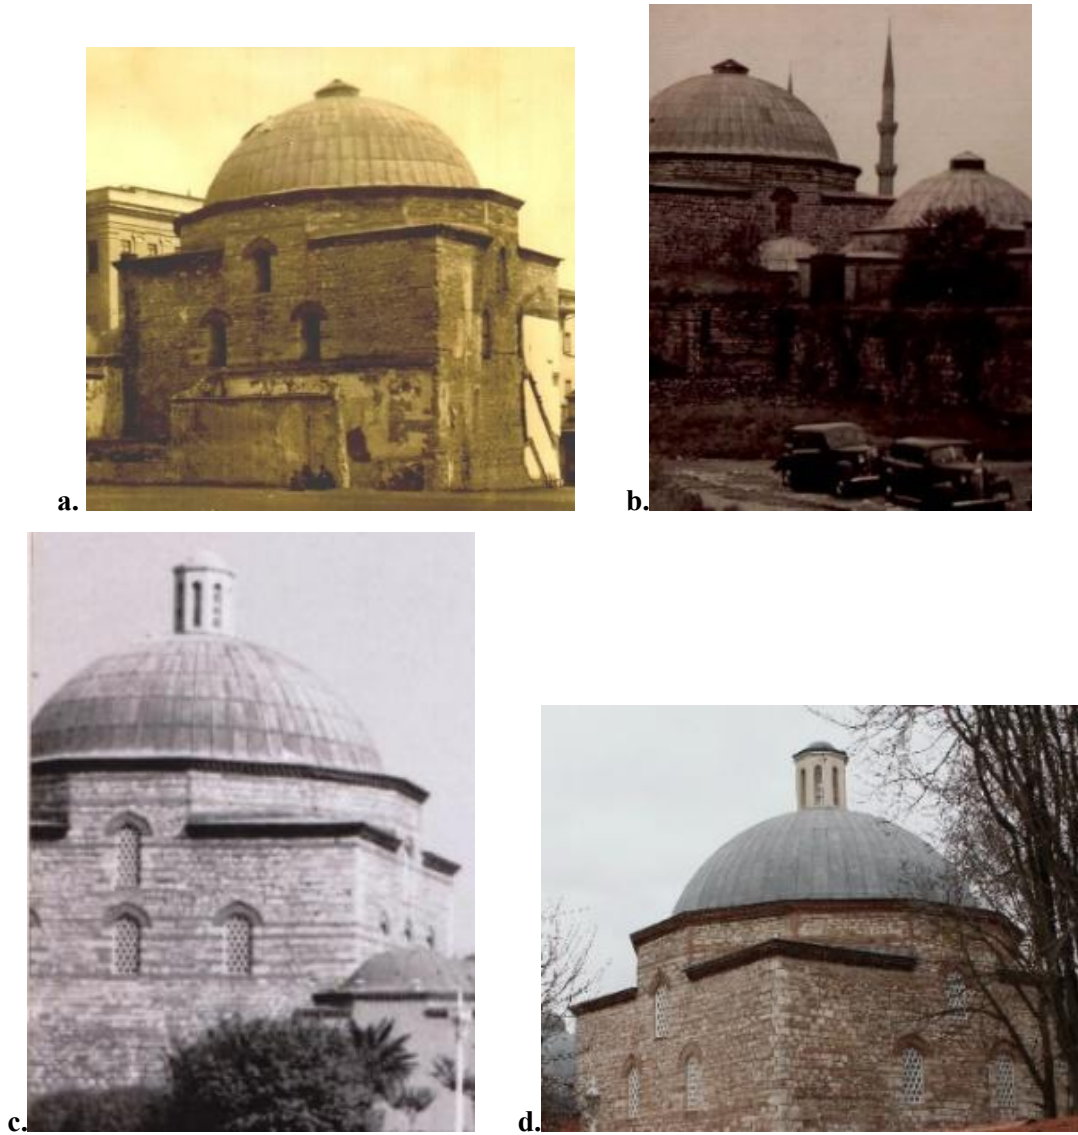
Image 14. Photographs showing the status of the light towers on the cold room domes in a. 1942, b. 1978, c. 1986, and d. 2010, respectively (author's archive).

The light lanterns, which are an important structural element for the natural lighting of the space on the domes of the cold sections, were in the same form in 1942 and 1978, as determined from the archive records, while the lanterns underwent formal changes in the restorations after 1978 and in 1986 (Image 14). In the restoration started in 2009, the period additions were renewed.

The dimensions of the lighting tower at the top of the dome of the men's cold room are 164 cm in diameter, narrowing in two stages to 154 cm and 148 cm. The same lighting opening

is also located in the women's cold room. The glass in this lighting space, which was originally closed with glass, was removed in the later restoration and replaced with a 410 cm high lantern from the inside of the dome. This lantern, which is 252 cm. above the upper level of the dome and finished with a 25 cm. thick molding, is covered with an 80 cm. high dome. The lantern with a façade width of 212 cm. is octagonal and has eight windows of 38 cm. width and 180 cm. height on each surface. The addition of a lantern of this size to the building increased the level of interior illumination.

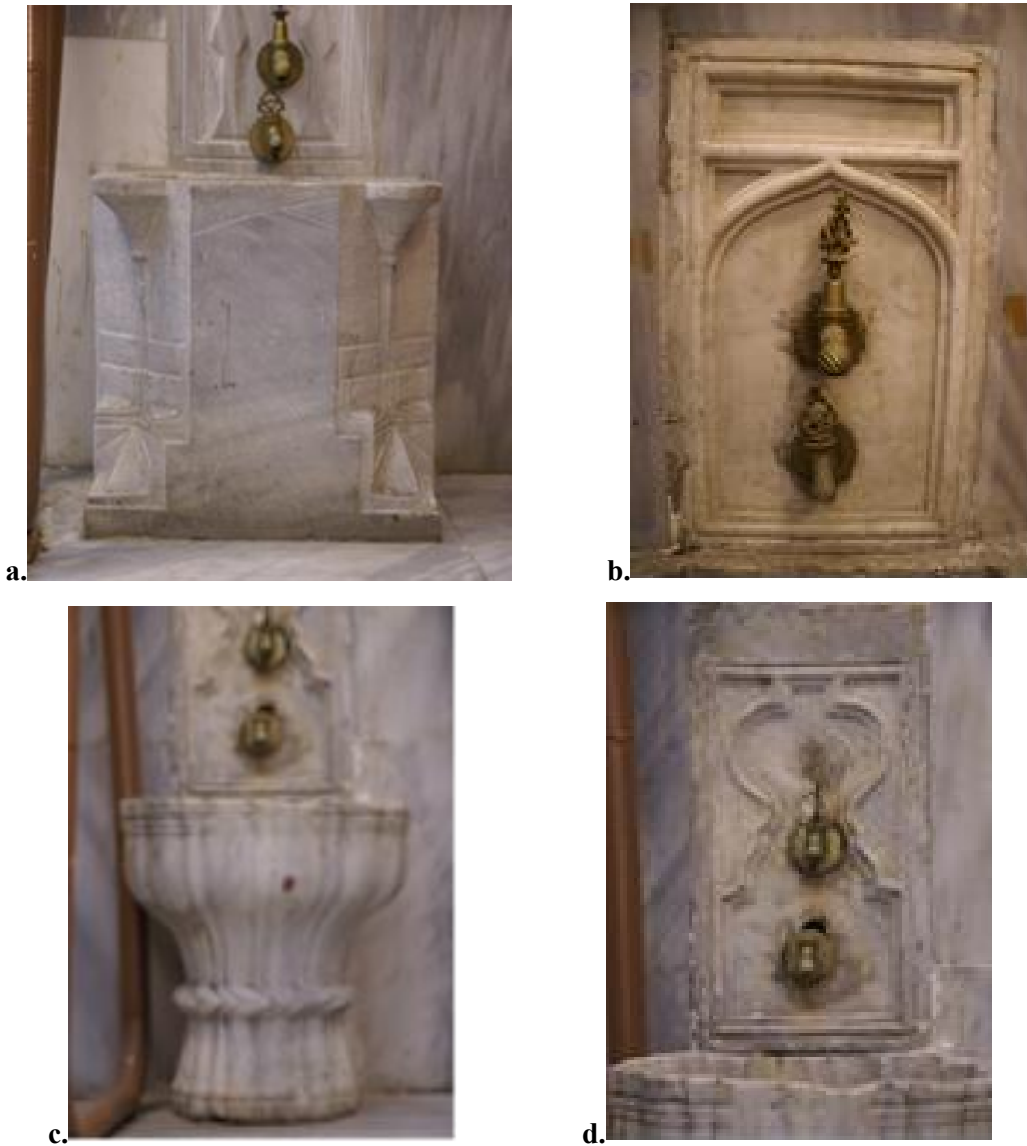
Image 16. a and b are the original bathhouse basins and mirrors of the men's, and c and d are the original mirrors of the women's warmth section of the bathhouse (author's archive).

After all the basins and mirror parts used in the warm and hot rooms were removed and recorded during the restoration works (Figure 16), they were handed over to the General Directorate of Foundations, and new basins made following the original were put into use. As can be seen from the drawings produced within the scope of the survey studies, gender differences and the effect of hierarchy -as seen in the sultan's basins- affected the shaping of the basins and mirrors. The applications made by adhering to these determinations allowed the values to be transferred unchanged.

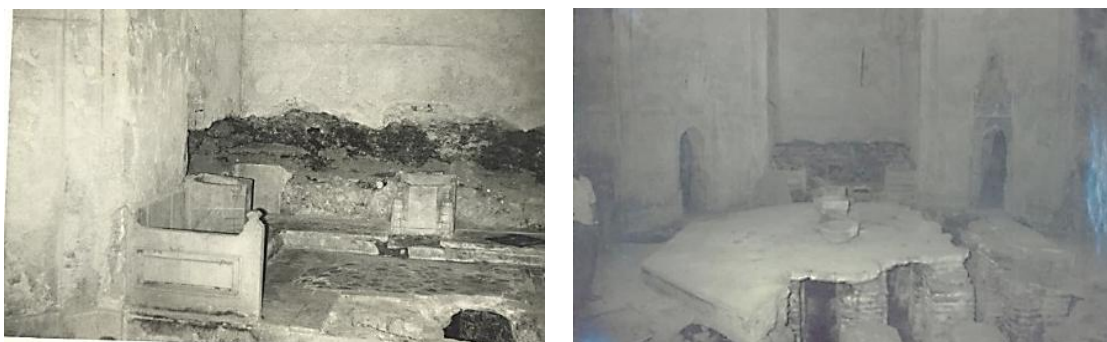
Image 18. The condition of the navel stone and sultan's iwan in the men's hot section from the archive records of 1978 taken from the General Directorate of Foundations.

While the two sides of the iwans meet in the form of a Bursa arch above, the same arch was formed with a 5 cm thread on the walls where the small cell doors are located. Thus, all octagon surfaces were made to feel identical. The surfaces of the Bursa arches were converted from octagons to circles using muqarnas, and a dome was created using a second circle. There is a smaller dome projection with a diameter of 160 cm in the center of the dome. During the 2009 restoration work, it was determined that the Seljuk motif used on the navel stone in the men's hot room was not original. According to the document obtained from research conducted in the photo archive of the General Directorate of Foundations, it was therefore believed to have been completed during the 1978 restoration (Image 18). Combining the navel stone fragments from the hypocaust used to heat the floors of the bathhouse, and the environmental excavations resulted in the creation of a new drawing, and it was determined that the current application of the navel stone was incorrect. The application of the navel stone was realized in this new drawing (Figure 18).

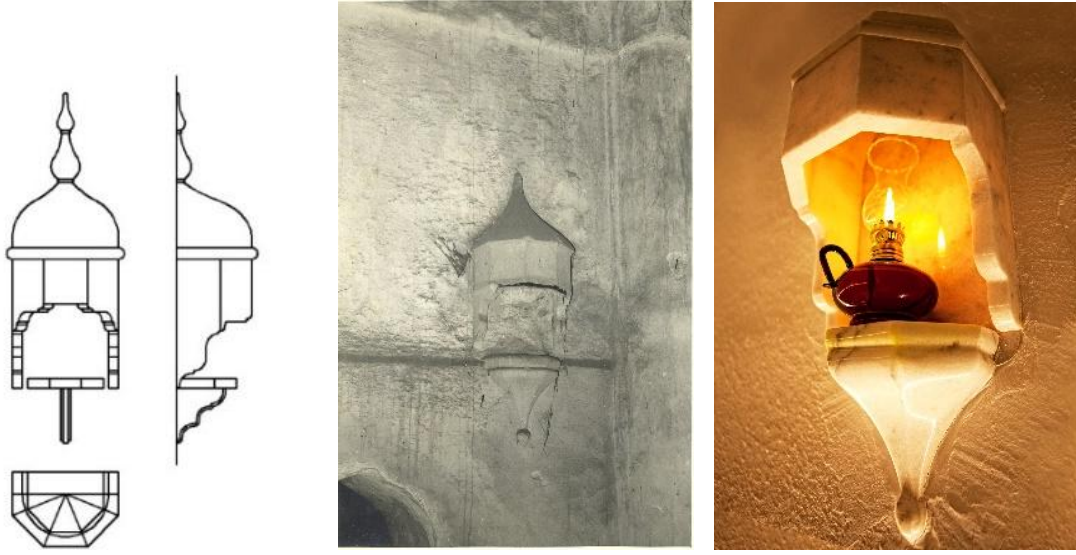
Image 21. Drawings of the Çerağman made on archival photographs and a photograph of the space before and after the application, 2020.

The arrangement of the basins and mirrors used in the warm section has the same features as in the hot one. Natural illumination is provided by revzen windows and light towers in the cold sections and by filigrees in the domes in the temperature and warm sections. It is known that the *çerağmans*, which is proof that the bathhouses were used even when there was no daylight, were the places where the lamps were placed in the evening. The *çerağman*, which was discovered during the survey in the small private cell on the right side of the men's hot room entrance, was found to be non-original after surface cleaning, and as a result of the research carried out, two original photographs were found, one dated 1920 and the other in Yılmaz Onge's book titled "Anatolian Turkish Bath and the Bathhouses Built by Architect Koca Sinan." From Ali Sami Ulgen's 1945 survey drawings of the Hagia Sophia Bathhouse, the current locations of the other *çerağmans* in the bathhouse were determined, and *çerağmans* were made and placed in their places. It was seen that the remains of the *çerağman* identified during the survey works were made of plaster, but during the restoration works, it was decided to make the new *çerağmans* from marble, taking into account the strength of the plaster material (Image21).

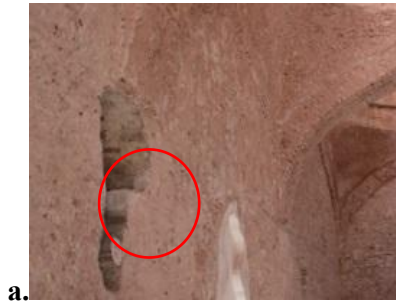
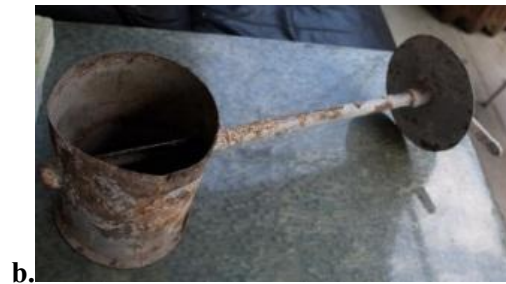
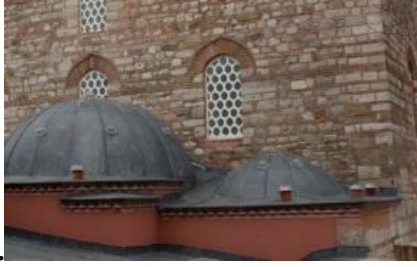
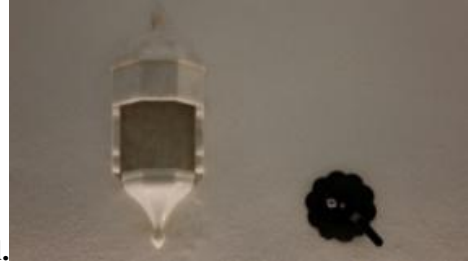
Image 22. a- 2009 restoration works - the condition of the ceramic pipes on the wall during the scraping process, b- the ceramic pipes removed from the wall, c- the ends of the ceramic pipes on the dome, d- the view of the ceramic pipes in the interior after restoration with çerağman (author archive).

During the 2009 survey work, while taking the measurements of the hypocaust space, the outlet openings of the vertical ceramic pipes, which allowed the fire burned in the ashray to be discharged from the roof through the body walls after circulating in the hypocaust and at the same time heating the bathhouse, were encountered. The temperature of the space can be regulated through a lever in the ceramic pipes. When the heat in the space is uncomfortable, it is possible to adjust the amount of heat transferred to the space by reducing or increasing the heat transfer by closing or opening the flap in the ceramic pipes through the lever, thus ensuring the thermal comfort of the space. Essentially, it is thought that this change is made seasonally depending on weather conditions. After the scraping process, traces such as intervention hatches, cracks, or later walling, etc., on the wall surfaces were followed, and the places where the ceramic pipes should be located were determined, and their roof openings were opened and found. The existing ones for maintenance and repair of the ceramic pipes adjustment elements have been taken under protection; the canceled adjustment cover holes have been opened again (Image 22).

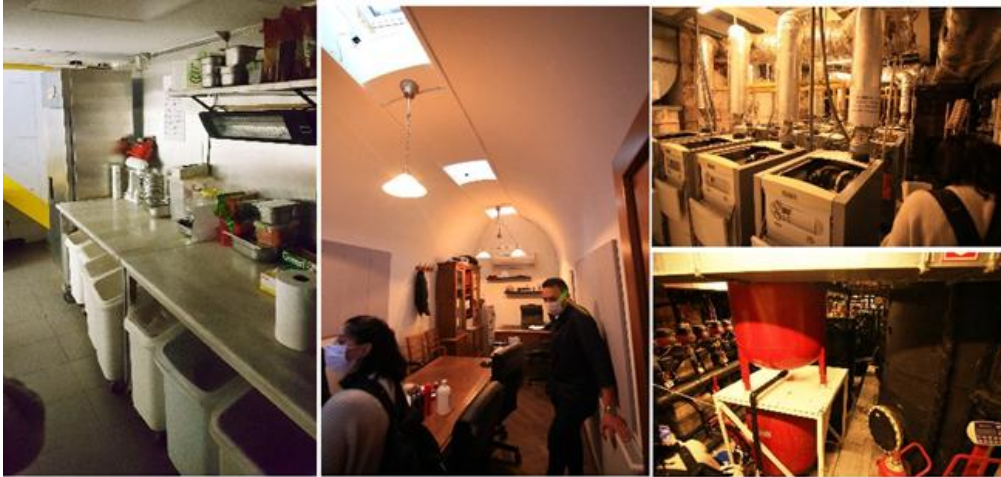
Image 23. During the re-functionalizing of the building, the upper level of the furnace, which was turned into two floors by taking advantage of its height, was converted into a kitchen area, the lower level into a plumbing room, and the cold water tank into an office area(author archive).

Another issue is the choice of heating system, and the spaces were re-functionalized for this reason. As a necessity of the era, the fuel used for the heating of the hammam was natural gas, which necessitated the installation of a new heating system. This situation brought an end to the heating of the floor, walls, and navel stone of the bathhouse with the fire and hypocaust system that was originally burned in the furnace. Although showing the heating systems inside the walls and under the floor stones in the warm sections to the people who will use the space through glass tiles is a positive effort to keep the original situation alive in the memory, just like in the previous restoration works, the installation of underfloor heating and natural gas system within the structure has been one of the applications that have been deemed necessary. As a result of this action, the hot water storage space, which was no longer needed, was replaced with staff rooms and logistics warehouses for the bathhouse employees; the cold water storage space was replaced with an office area, and the furnace was replaced with a kitchen area for food and beverage services (Image 23).

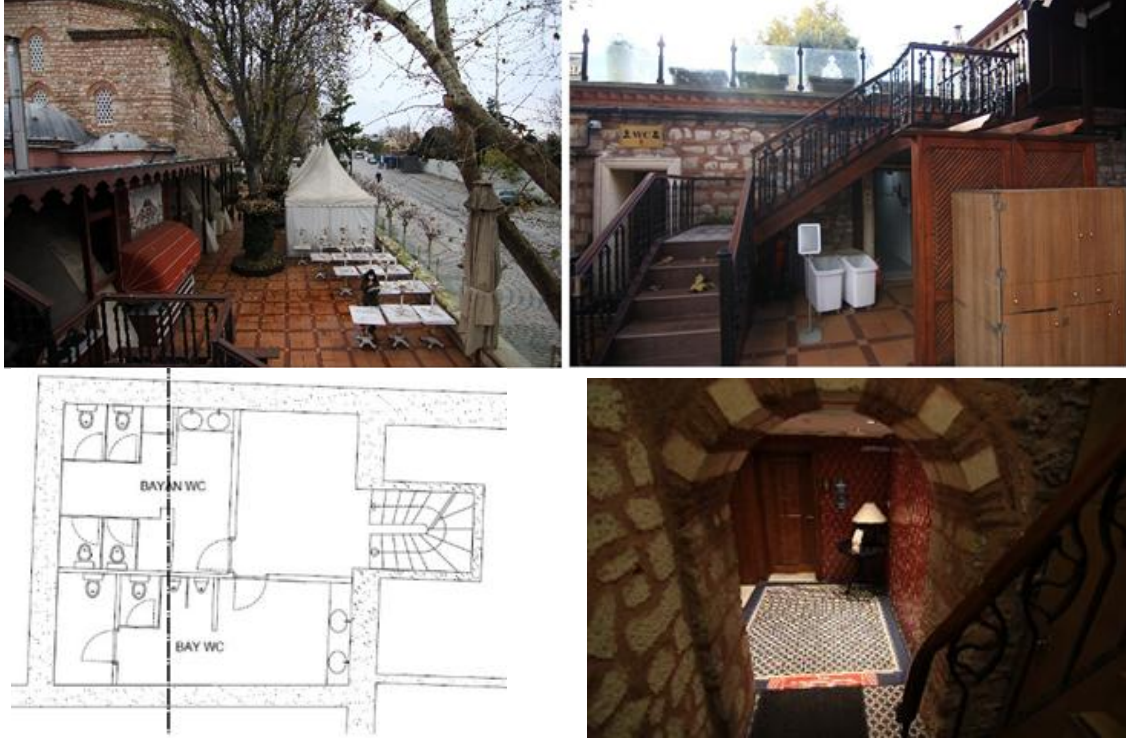
Image 23. The additions made to the facade of the building to provide the expected comfort level and service variety in the restaurant services provided by the business prevent the perception of the facade and the integrity of the building. Survey drawings of the restrooms built with a new project on the lower elevation of the furnace and a photograph of the entrance to the space (2021).

With the arrangements made in recent years, the placement of the food and beverage service area in front of the entrance of the men's section of the bathhouse and above the furnace area with ciborium and umbrellas that protect the users from weather conditions has reached a level that poses a problem in the perception of the architectural structure of the building from outside. For those who come to receive food service from the establishment, toilets were built

on the lower level of the furnace area where the fuel tank used to be located. This intervention threatens the originality of the building (Image 23).
