# Osmanlı Mirası Araştırmaları Dergisi

Cilt 13 Sayı 36, Temmuz 2026 / Volume 13, Issue 36, July 2026

## ***Rural Ottoman Heritage and Vernacular Timber Mosques: Documentation of the Çantı Technique in Northwestern Anatolia***

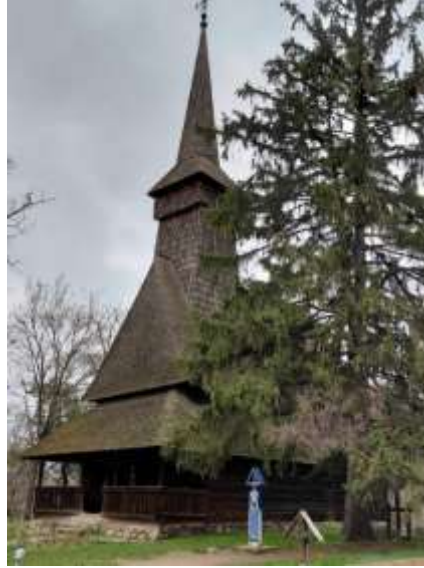
Figure 1. Church 1722, Dimitrie Gusti National Village Museum, Photograph by the author, 2025

reconstructed within the museum area<sup>22</sup>. Figures 1 and 2 illustrate a timber church structure and its dovetail jointing detail from the Dimitrie Gusti National Village Museum.

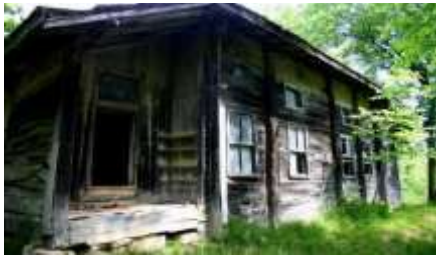
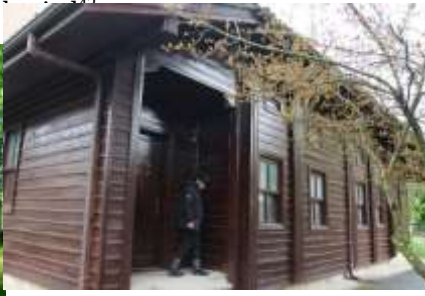
Figure 4. Photograph by the author, 1998      Figure 5. Photograph by the author, 2025

The mosque located in Büyük Kaynarca Village was constructed along the stream bank. A new mosque has subsequently been built adjacent to the southern façade of the original structure.

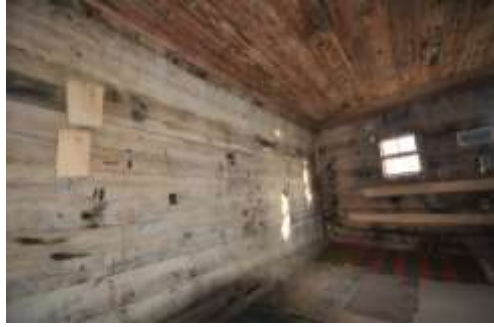
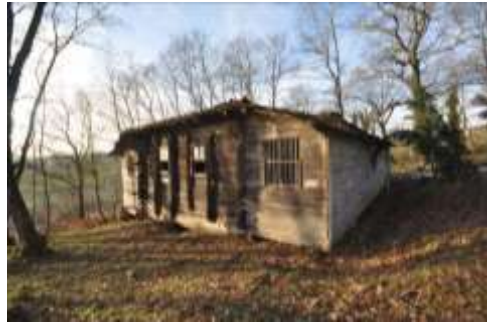
The Kocaeli Orhan Gazi (Işıklı) Mosque, located in Bağlıca Village of the İzmit District in Kocaeli, does not have a precisely documented construction date<sup>45</sup>. Figures 8 and 9 document the pre-restoration condition of the Kocaeli Orhan Gazi (Işıklı) Mosque. The images reveal material deterioration and structural weakening. This demonstrates the vulnerability of timber structures to environmental exposure and lack of maintenance.

Figure 8. Kocaeli Orhan Gazi (Işıklı) Mosque in its pre-restoration state. Photograph from the archive of the Kocaeli Regional Council for the Conservation of Cultural Heritage (KVKBK)

Figure 9. Kocaeli Orhan Gazi (Işıklı) Mosque in its pre-restoration state. Photograph from the archive of the Kocaeli Regional Council for the Conservation of Cultural Heritage (KVKBK)

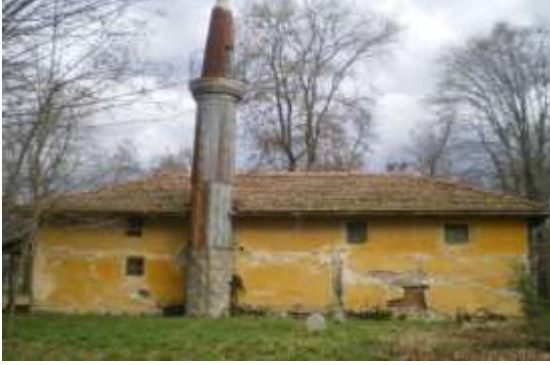
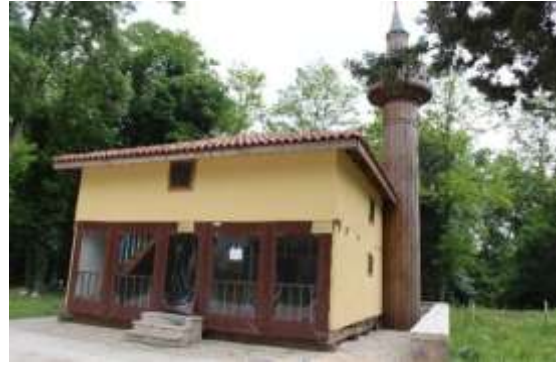
The roof is constructed as a gable roof and covered with tiles. The foundation system remains legible and has survived in a relatively intact condition. Both interior and exterior architectural elements have largely preserved their original characteristics. The floor structure is

supported by stone bases, with timber elements placed upon them. The load-bearing walls consist of timber elements interconnected using the Çantı (interlocking) technique.

The timber elements used in the walls vary in size, with approximate thicknesses of 10 cm, widths of 30 cm, and lengths ranging from 250 cm to 350 cm. Timber flooring elements are approximately 5 cm thick, 25 cm wide, and range in length between 180 cm and 250 cm. The structure is single-storey, with the gallery (*mahfil*) arranged as an intermediate mezzanine level. Figures 15 and 16 present the plan and spatial organization of the Büyük Esence Mosque. The drawings show a rectangular layout combined with a gallery (*mahfil*) system. This demonstrates both typological continuity and functional adaptation within the Çantı system.

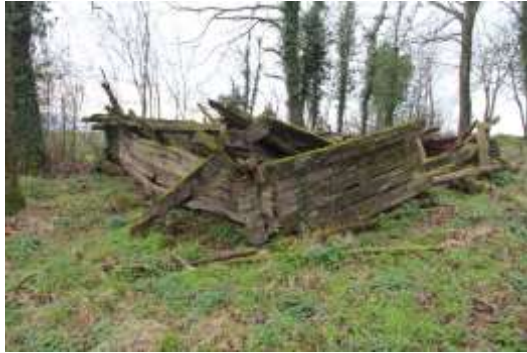
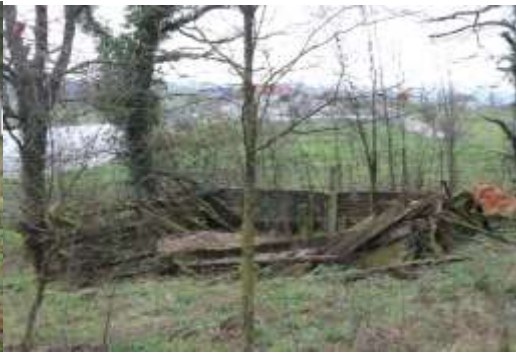
The Sultan Orhan Fetih Mosque, located along the roadside between Döngelli Neighborhood and Kütükçüler Village in the Kandıra District of Kocaeli Province (Figures 3 and 21), has been completely demolished. Figures 19 and 20 document the current state and location of the demolished Döngelli Mosque. The absence of the structure, despite its registered status, highlights a critical conservation failure. This demonstrates the consequences of inadequate protection and delayed intervention.

Although parts of its cemetery (*hazire*) remain, the mosque itself no longer survives. The structure has been officially registered; however, restoration work has not yet commenced. Based on available documentation, the mosque exhibited similarities in plan typology to the Kocaeli Orhan Gazi (Işıklı) Mosque and the İncecik Mosque.

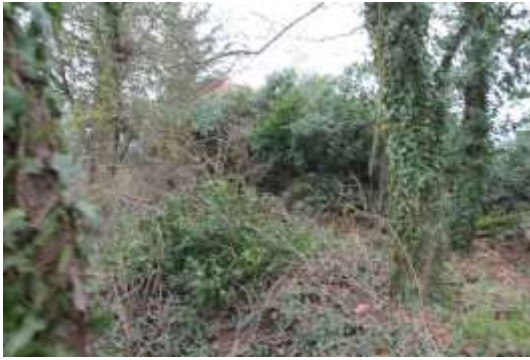
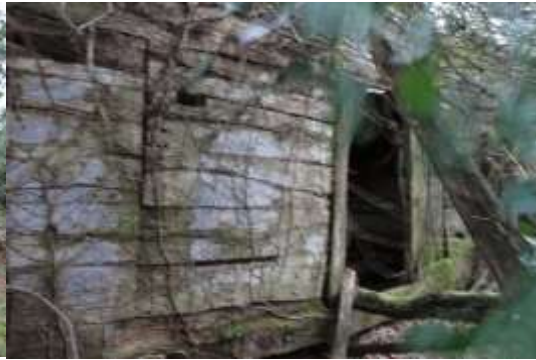
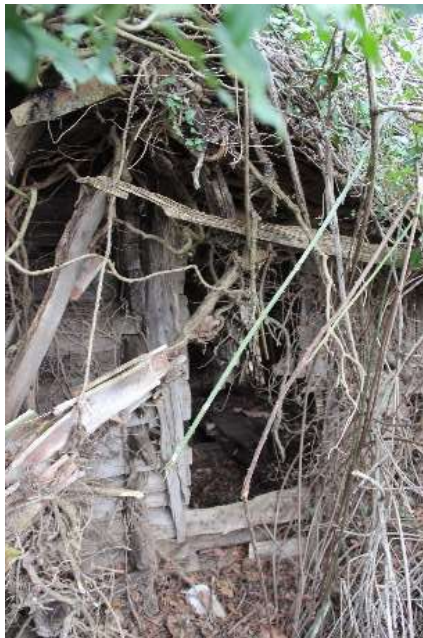
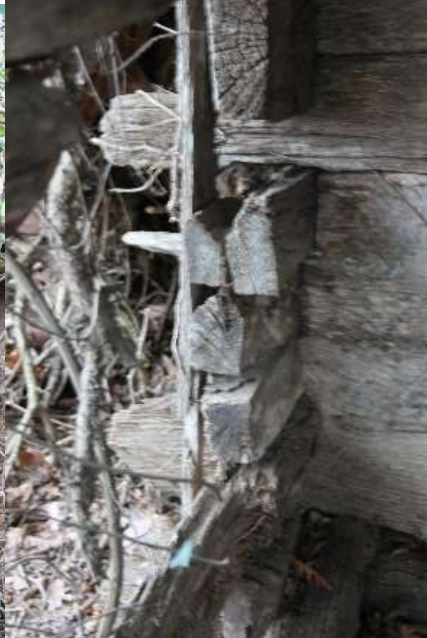
The İncecik Mosque, located along the roadside between İncecik and Mancarlar villages in the Kandıra District of Kocaeli Province<sup>47</sup> (Figures 3 and 26), is currently in a severely deteriorated condition and is largely covered by dense vegetation, including thorny shrubs and trees. Figures 22–25 show the severely deteriorated condition of the İncecik Mosque. The structure is largely overgrown and partially collapsed. This indicates the risks faced by unregistered heritage structures and underscores the urgency of documentation and protection.

Archival research conducted at the Kocaeli Regional Directorate for the Conservation of Cultural Heritage revealed no official documentation regarding the structure, and it was confirmed by the institution that the mosque had not been registered.

The findings obtained through field surveys conducted as part of this research were shared with the relevant authorities, contributing to the initiation of the registration process. In terms of plan typology, the İncecik Mosque exhibits similarities with the Kocaeli Orhan Gazi (Işıklı) Mosque and the Döngelli Mosque located in Bağlıca Village, Kandıra District (Figure 26.).
