Osmanlı Mirası Araştırmaları Dergisi

Ayşe Esin KULELİ

An Ottoman Period Addition to Attaleia Castle: Antalya Clock Tower

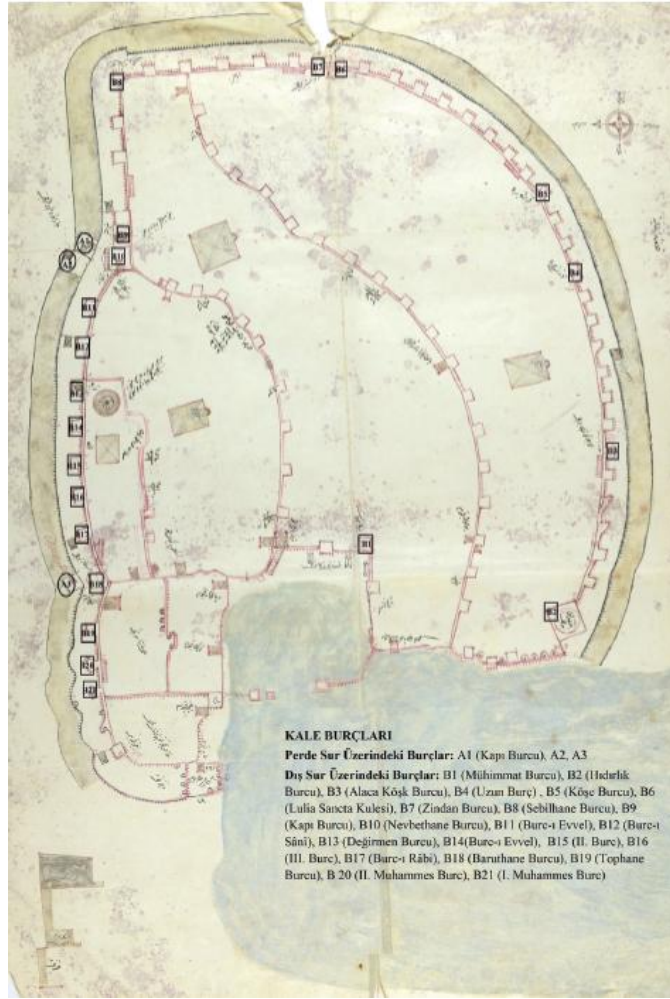
Figure 2. Architect Mustafa Raşid Efendi's map dated 1815.¹⁷

The maps by Mustafa Raşid Efendi in 1815 (Figure 2) and Lieutenant Ali Rıza Efendi in 1905 (Figure 3), prepared approximately a century apart, show the outer and curtain walls, inner walls, castle gates, bastions, and ditches, that constitute Antalya Castle. These maps, prepared by state officials for different purposes in the context of restoration and investigation of the damage caused in the castle, have been extensively examined in Dayar's research. In his study, the researcher conveyed data and opinions regarding this significant defence system.¹⁵¹⁶

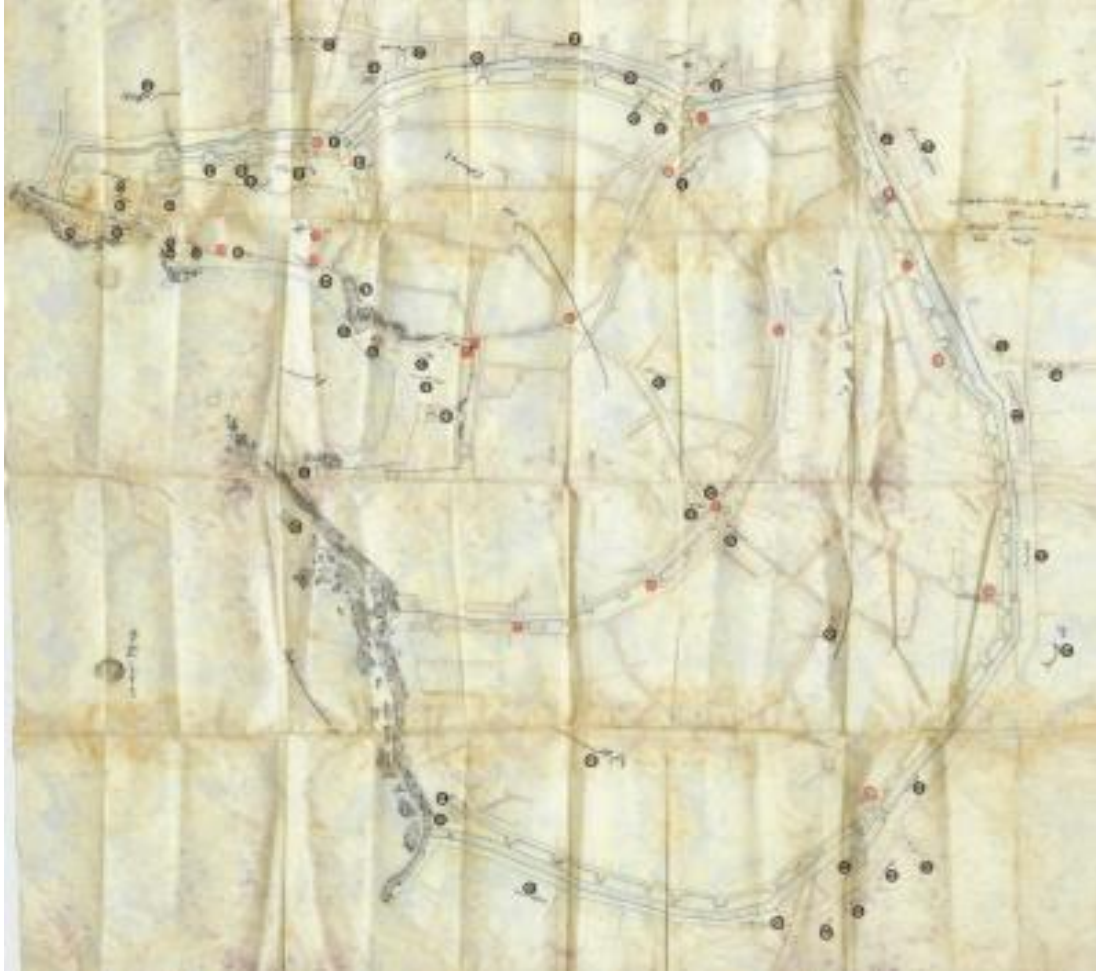
Figure 3. Map of Lieutenant Ali Rıza Efendi, dated 1905.¹⁸

The 1905 map, predating the systematic destruction of Attaleia Castle, which carried out between 1911 and 1936, provides insight into the defence system of the settlement in the historical city center of Antalya, and the historical development experienced in the city until the early 20th century.¹⁹

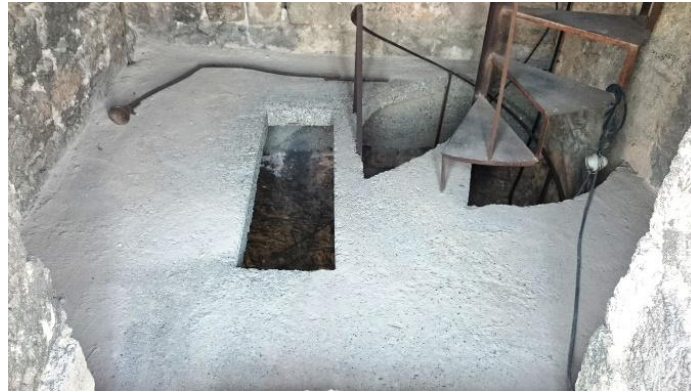
Figure 8. Reinforced concrete slabs and iron staircase.

It is not possible to enter to the inside of the bastion in the lower levels and it can be understood from section drawings that the bastion's center is filled. Access to the interior can be achieved through a simple modern iron staircase on the northeast facade and there is an iron gate on the southeast facade. The interior of the clock tower consists of four floors at different heights. Access between the floors, which are separated by reinforced concrete slabs, is provided by an iron spiral staircase (Figure 8). Entry to the tower can be accessed through the added door at an elevation of +7.31, which is the lowest walkable level within the tower. A circular iron staircase is placed in the western corner of the rectangular interior space (200x340 cm). The wall thickness of the tower at this level has been measured at 270-280 cm, with a distinctive original arrow slit window also drawing attention.

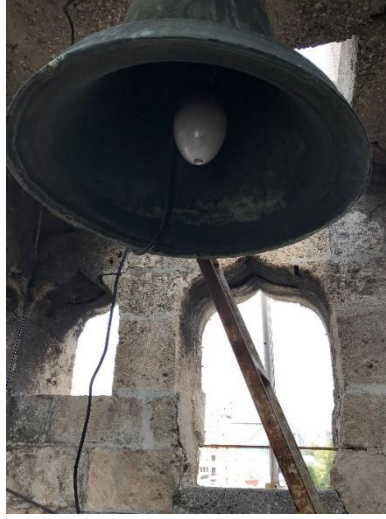
Figure 9. One of the bells with a lamp is mounted on the reinforced concrete slab in the clock pavillion section.³⁶

One of the bells is mounted on the reinforced concrete slab at the top of the tower (Figure 9), and the other is placed inside one of the arched openings at the same level. There are twelve window openings in the top floor in total.

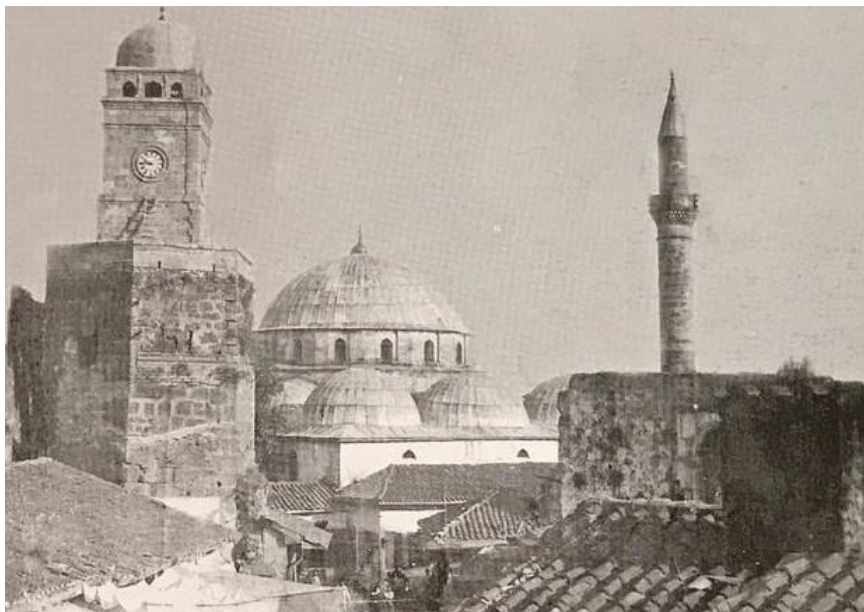
Figure 15. Antalya Clock Tower and Tekeli Mehmet Pasha Mosque.⁴⁴

The Antalya Clock Tower is situated on the top of the bastion B50, which is part of the historical city walls, rather than being independently located in the city square (Figure 15).

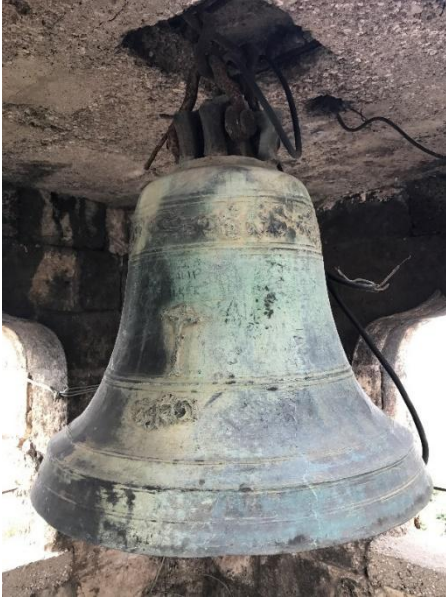
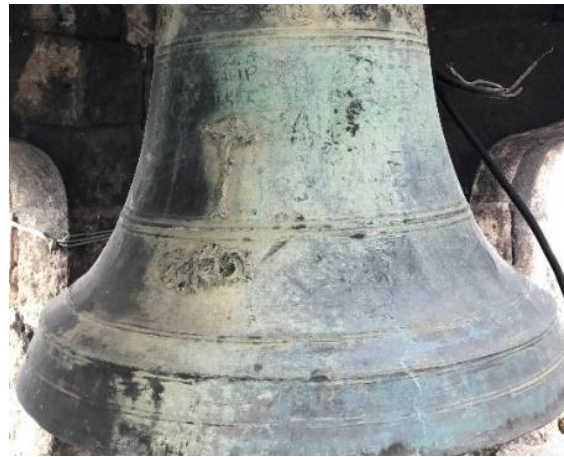
Figure 18a. Bell hanging on top of clock tower 18b. Decorations and the graffiti on the surface.

There are partially discernible figurative decorations on the hanging bell at the top of the clock tower. According to Acun, the bell features "a relief of Jesus on the cross, an orant position of Mary, and a depiction of a Saint".⁵¹ The decorations on the surface of the bell, which is 71 cm in diameter and 71 cm in height, are worn, and the graffiti on the surface is notable. At the bottom of the bell's surface, there is an inscription in Greek that reads, 'In the name of the church of the Virgin in Attaleia'.⁵² This inscription informs us that the bell was made for the

church of the Virgin in Antalya (Figure 18a, 18b) and this church, located within the Kaleiçi, is now used as the Alaaddin Mosque. On the surface of the smaller bell, no decoration is observed (Figure 19). In an old photograph, another bell, which was likely rung manually and is no longer present in the structure, is seen hanging from a wooden supporting system in the terrace section of the tower. (Figure 20, 24).

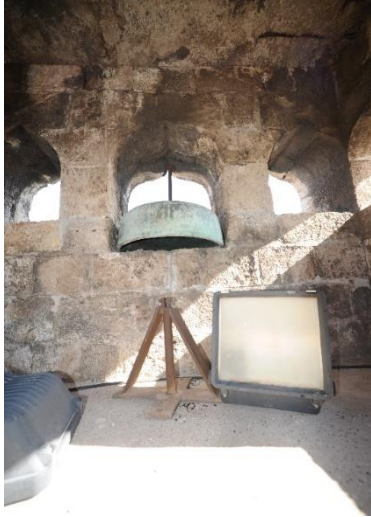
Figure 19 Other bell, smaller in size and undecorated.

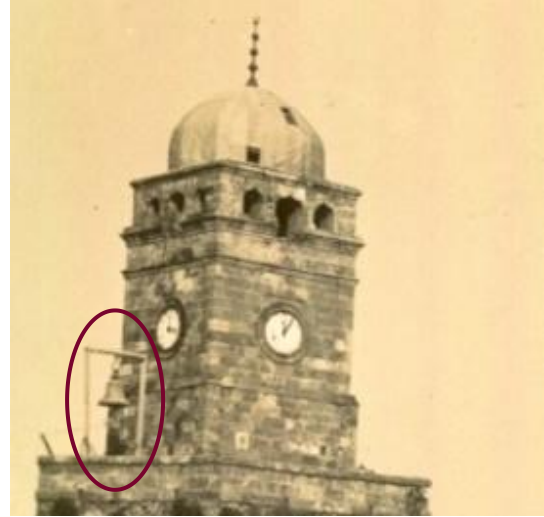
Figure 20 Another bell seen in the terrace section of the tower in an old photograph.

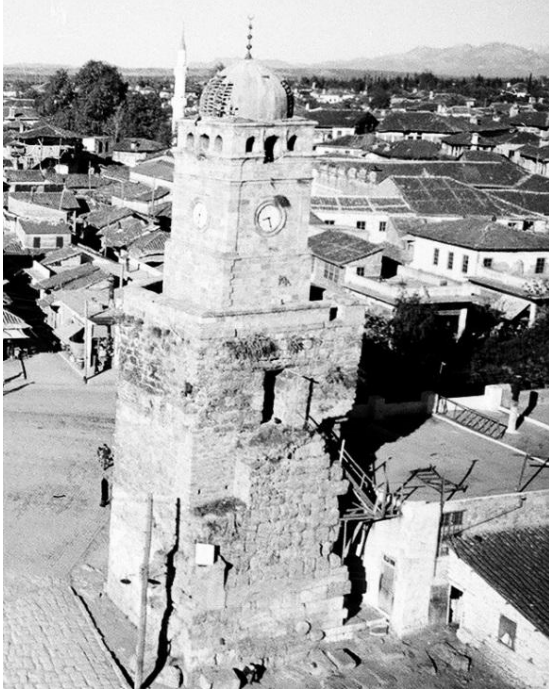
Figure 23. Photograph after the storm⁵⁸ (left).

The interior of the square-plan clock tower, constructed onto the pentagonal tower is organized into four stories tall in connection with the tower. At the top level, the roof of the pavilion was covered with an onion shaped dome. The form of the dome was created with a wooden structure, supported by baghdadi laths. It can be understood from examining old photographs (Figure 23) that the dome was damaged in a storm, causing the lead coverings to be damaged and the Baghdadi laths to be exposed.

Although the structure was originally covered with an onion-shaped dome (Figure 19, 23, 24), as seen in Sultan Abdulhamid period structures, due to damage caused by a storm in 1942 (Figure 25a, 26a, 26b), later loopholes were constructed instead of the dome (Figure 25b, 25c).

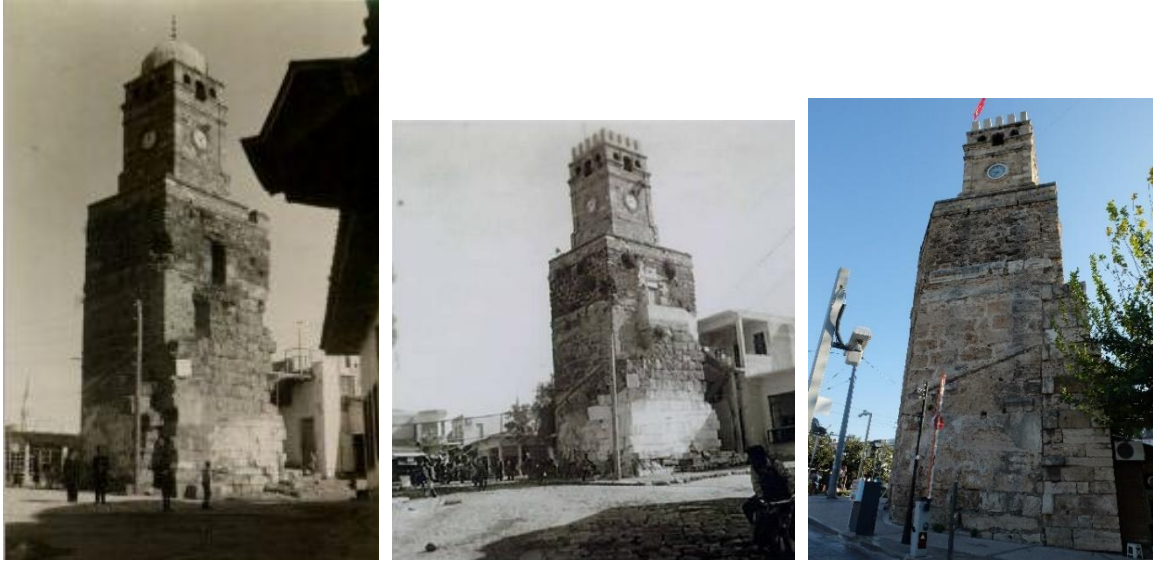
Figure 25. From left to right; 25a, 25b, 25c. View of the Antalya Clock Tower and the bastion on which it is located in 1938, 1960, and 2018. (25a, 25b⁵⁹, 25c Author's Archive).

1930s and was repaired again in 1967 due to the damages especially in the lower parts of the tower. During this process, loopholes were built instead of the dome and the southeastern facade wall was repaired, and the empty spaces on the facades were filled in.⁶⁰

The dome was covered with lead plating. However, instead of repairing the damaged dome during the execution works, a structure resembling a loophole with imitation stone was made. This application, which creates the perception of a castle wall / bastion at the top of the clock tower in the recent past, is incompatible with the original architectural quality of the building. It is known that the restoration works of the Clock Tower which is an iconic building in the city, continue nowadays in a manner that respects the original values of the structure.
